Tire-Derived Aggregate: Settlement in Road Slide Repair

Analysis Of Marina Drive, Geysers Road, Sonoma Mountain
Road, Palomino Road, Italian Bar Road, Moran Road, And
Ortega Ridge Road Repair Projects

December 2023

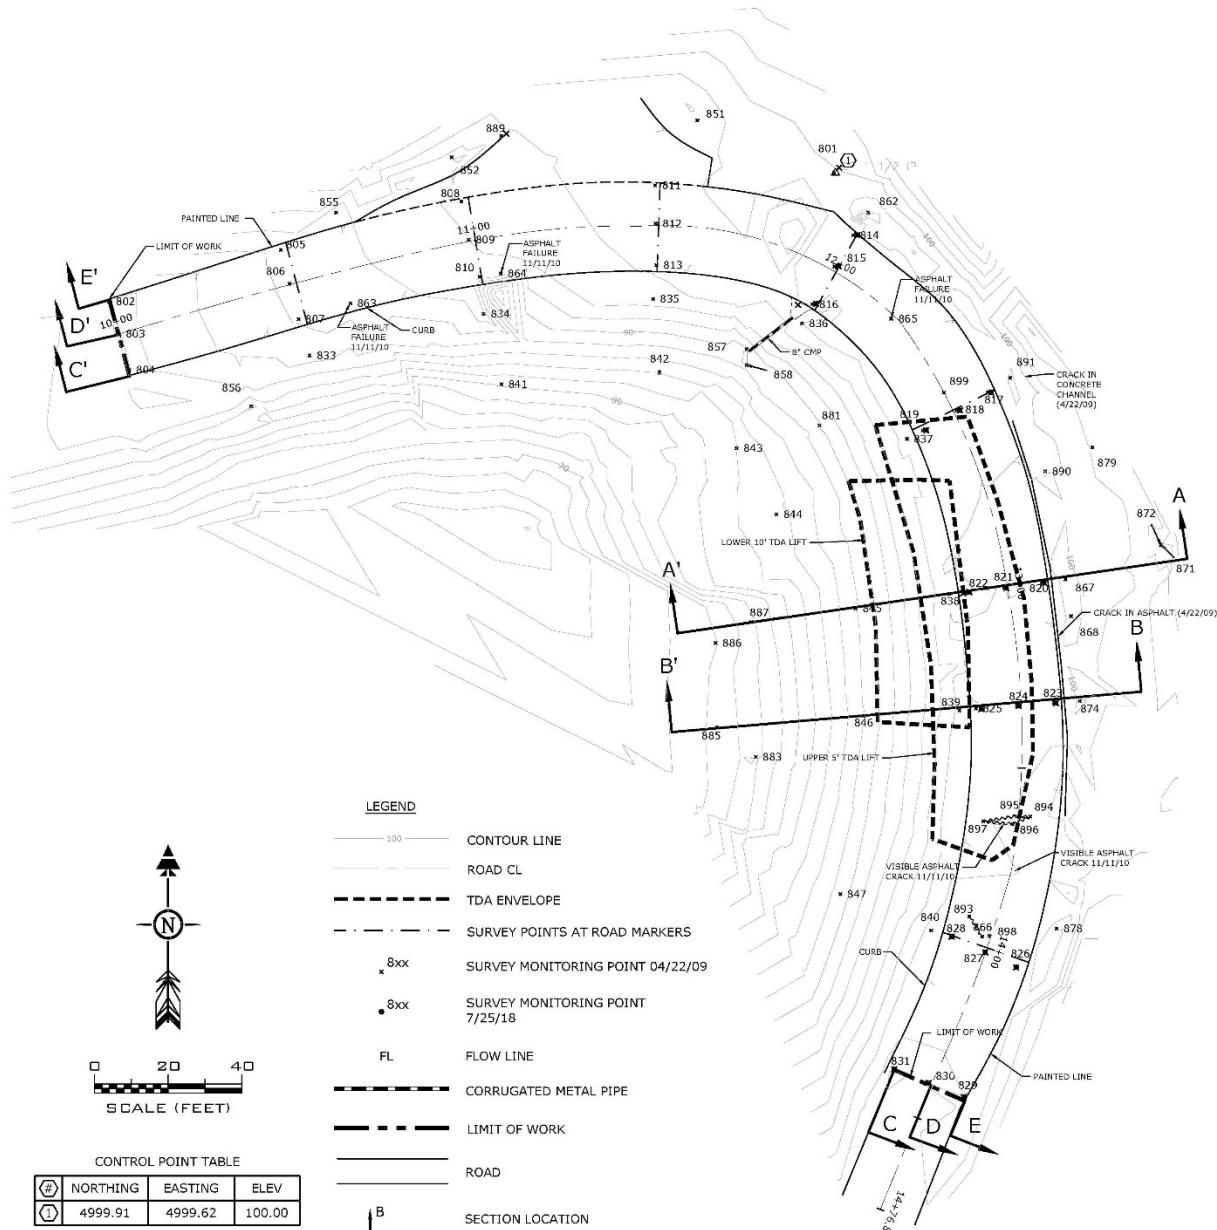
Figure 3. Detailed Drawings, Marina Drive

To date, the cross-sections A-A' and B-B' through the TDA fill portions of the Marina Drive repair (Points 820, 821, 822, 823, 824, 825) have shown an overall average settlement of 0.44 feet (5.28 inches) since the completion of construction in 2007. The approximate maximum settlement found was 0.63 feet (7.56 inches) at survey point 824, located along the centerline of the road (refer to Figure 3).

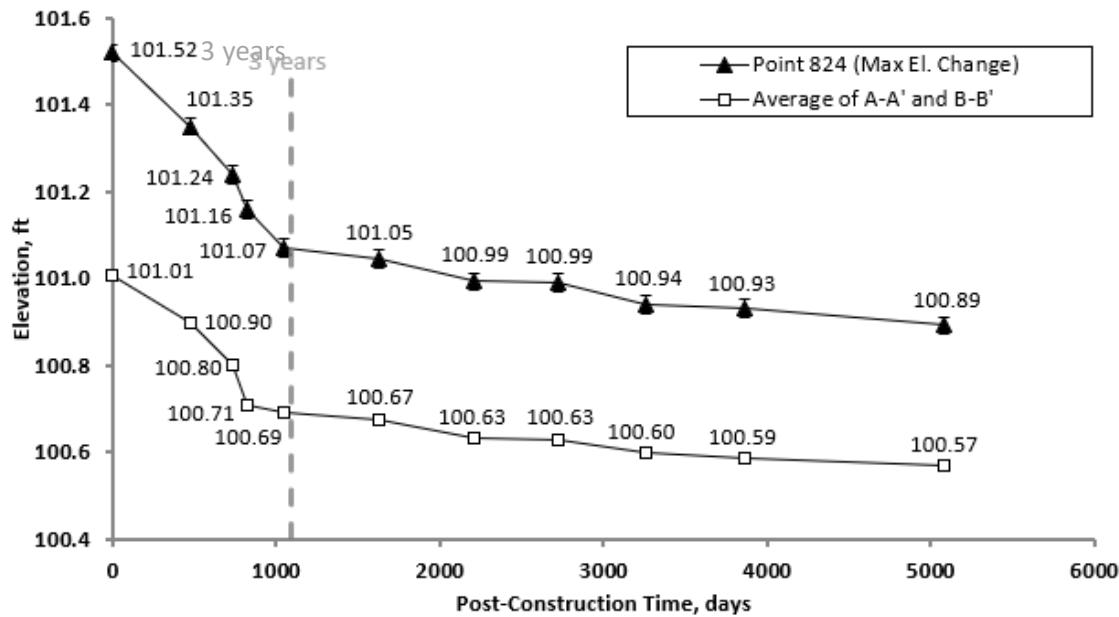
Figure 4. Average and Maximum Elevation Change vs. Time at Marina Drive

Since the November 2010 survey event, the survey data from the Marina Drive Project Site indicated that the settlement rates of the TDA-associated road repair have now reached levels below or close to the survey accuracy threshold for this site. The average elevations of the three most recent survey points (2016, 2018, 2022, respectively) fall within the sampling error range. It appears that the site has substantially stabilized approximately three years after the completion of construction and has remained stable for three consecutive survey events. Therefore, settlement is generally considered complete.

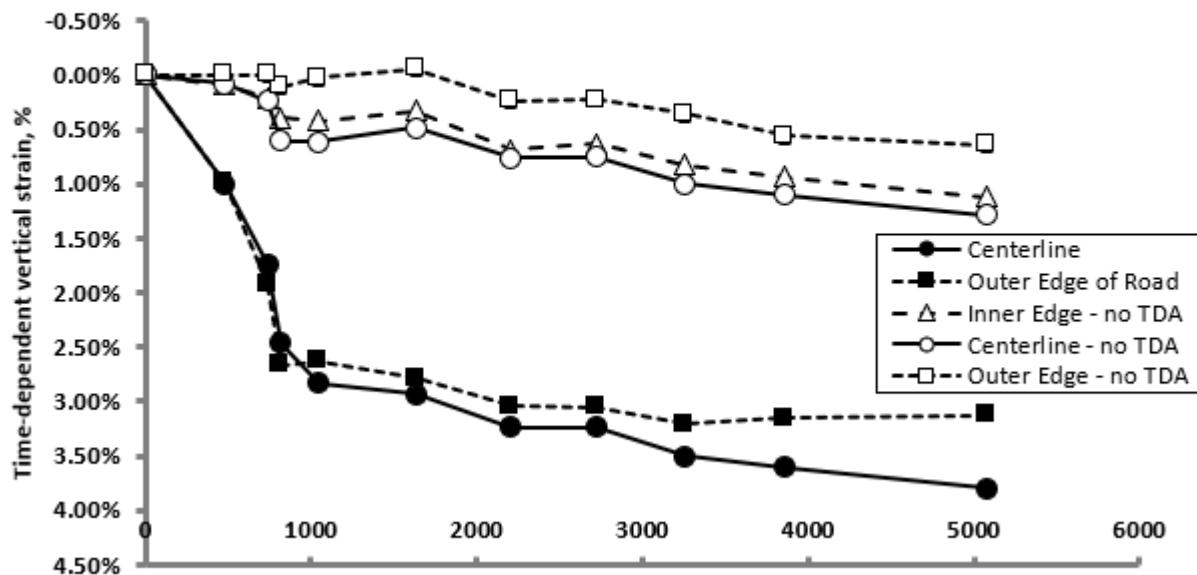
Figure 5 Marina Drive: Time-dependent Settlement for the Inner Edge, Outer Edge, and Centerline Alignments

Figure 5 depicts strain of approximately 3.7% was observed for the average centerline of the 15-foot TDA fill, corresponding to slightly over 6 inches of pavement settlement from the project completion in 2007 to the latest survey in 2022. While the average centerline data shows a continued increase in vertical strain, this trend is also reflected in the soil centerline data points, indicating that the increased strain may be uniform for the entire site.

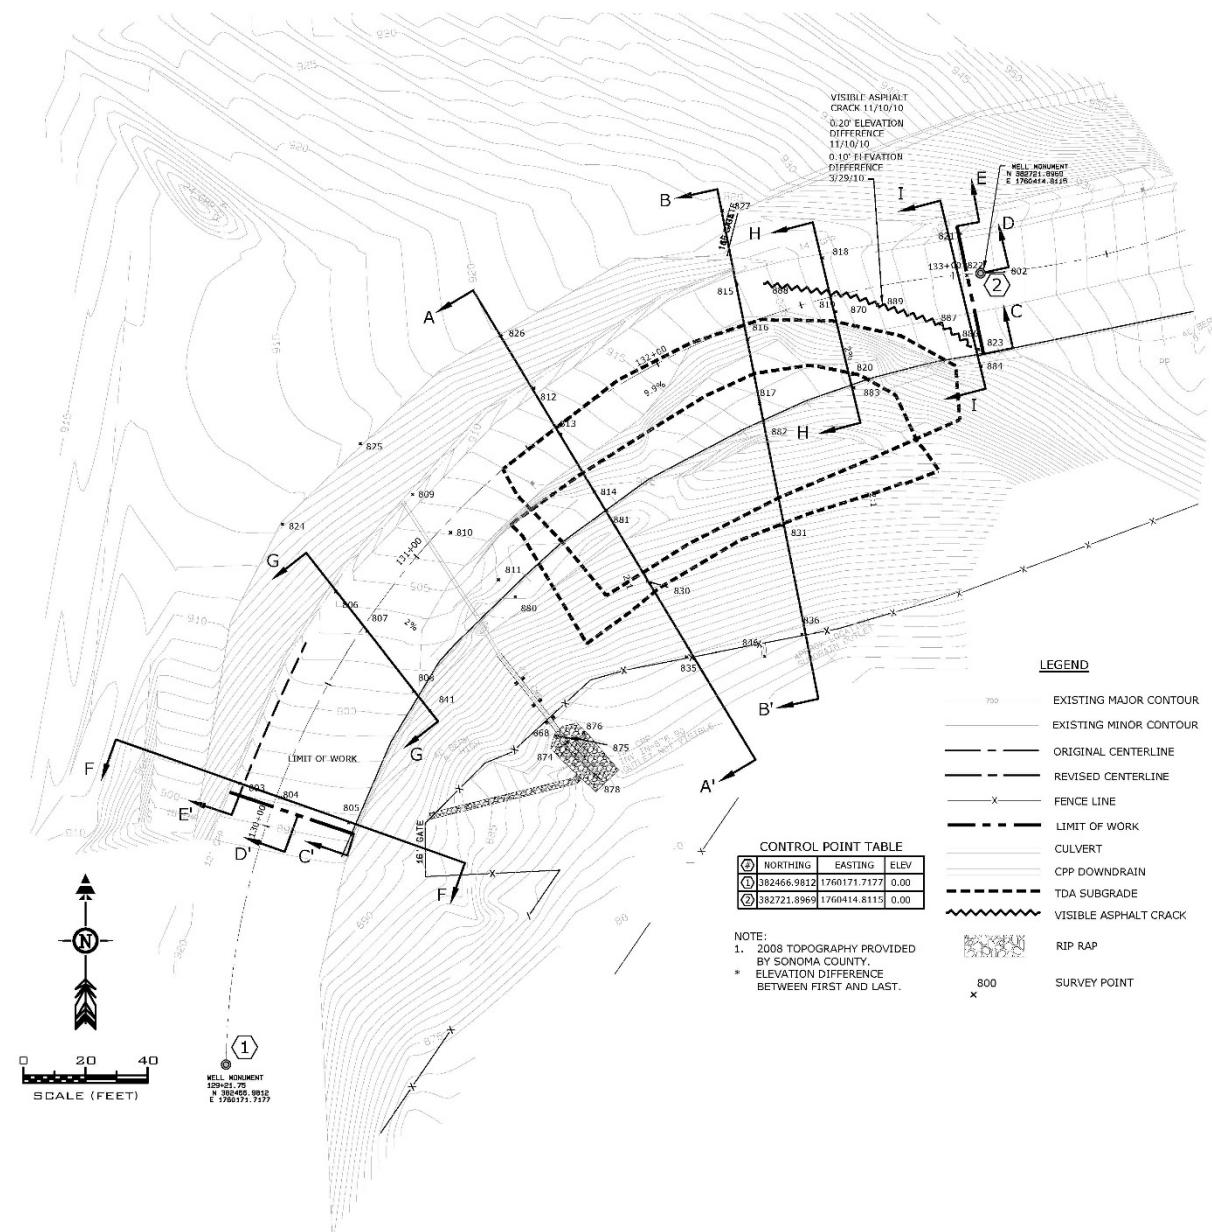
Figure 6. Detailed Drawings, Geysers Road

The cross-sections A-A' and B-B' through the TDA fill portions of the Geysers Road repair have an overall average settlement of 0.21 feet (2.52 inches) since the completion of construction. The approximate maximum settlement observed was 0.50 feet (6 inches) at survey point 817. (refer to Figure 6).

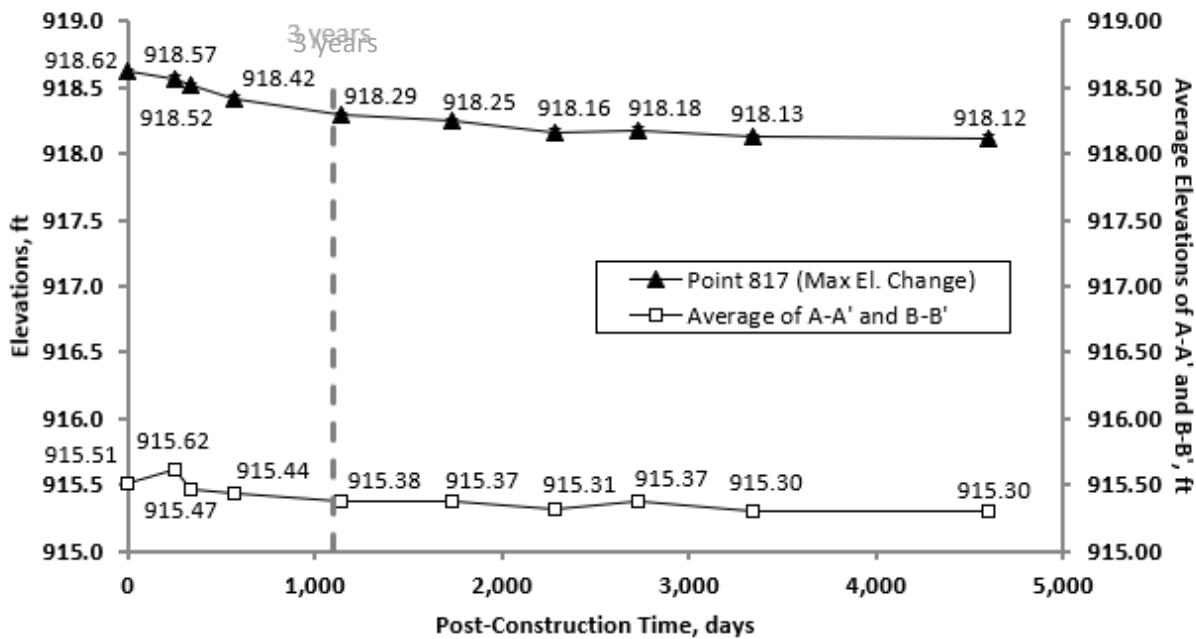
Figure 7. Average and Maximum Elevation Change vs. Time at Geysers Road

The general trend of the settlement curve for Geysers Road resembles that of Marina Drive, showing a high settlement rate for the first three years (steeper slope), followed by a slower settlement rate. The site appears to have substantially stabilized around three years after the completion of construction. The maximum elevation change point was Point 817, which remained stable for two consecutive survey events: June 19, 2018 and November 30, 2021. The time-dependent settlement curve for Geysers Road (Figure 8) indicates that all survey elevations in 2018 matched those of the 2021 survey.

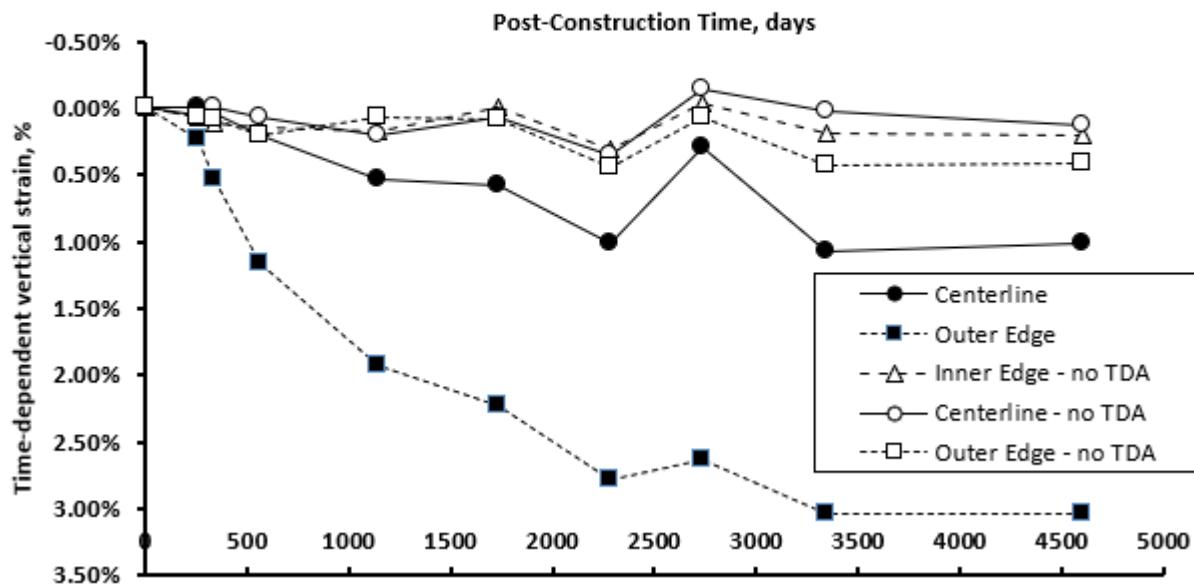
Figure 8. Geysers Road: Time-dependent Settlement for the Inner Edge, Outer Edge, and Centerline Alignments

A visible crack in the asphalt road surface on the eastern side of the Geysers Road TDA fill has been present since the 2012 survey (refer to the Photo Log in Appendix B). This crack aligns with the underlying differential between soil and TDA in the subgrade fill. During the construction phase, it was observed that the contractor (Sonoma County) excavated the eastern side of the repair differently from the construction drawings, resulting in a relatively abrupt transition between TDA and soil in the underlying subgrade fill. This could have influenced the visible crack in the road surface. However, the crack did not pose a driving hazard and has since been repaired. Average elevation data from 2018 to 2021 shows that the TDA fill volume under the road surface does not show signs of increased settlement.

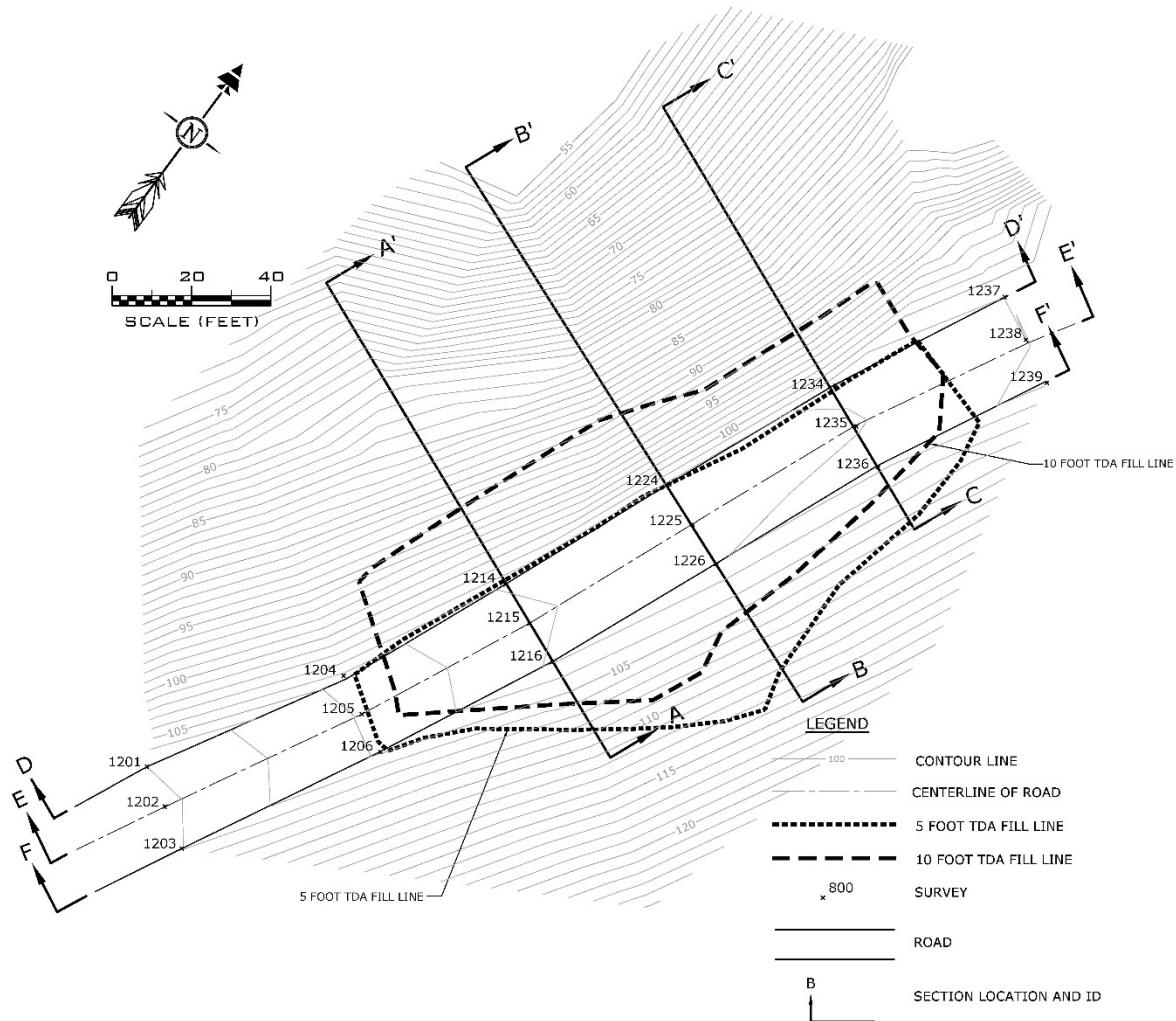
Figure 9. Detailed Drawings, Sonoma Mountain Road

The cross-sections A-A', B-B', and C-C' through the TDA fill portions of the Sonoma Mountain Road repair indicate an overall average settlement of 0.44 feet (5.28 inches) since the completion of construction. The approximate maximum settlement observed was 0.69 feet (8.28 inches) at survey point 1204 (refer to Figure 9).

Analysis of the average settlement between 2018 and 2021 for this site reveals no settlement of the TDA fill, however, there is a slight increase in elevation at point 1204. This data point was derived from the asphalt surface and not from the previously installed survey nail, which could not be located. Consequently, this data point may potentially reflect the same value as the previously recorded 2018 elevation data.

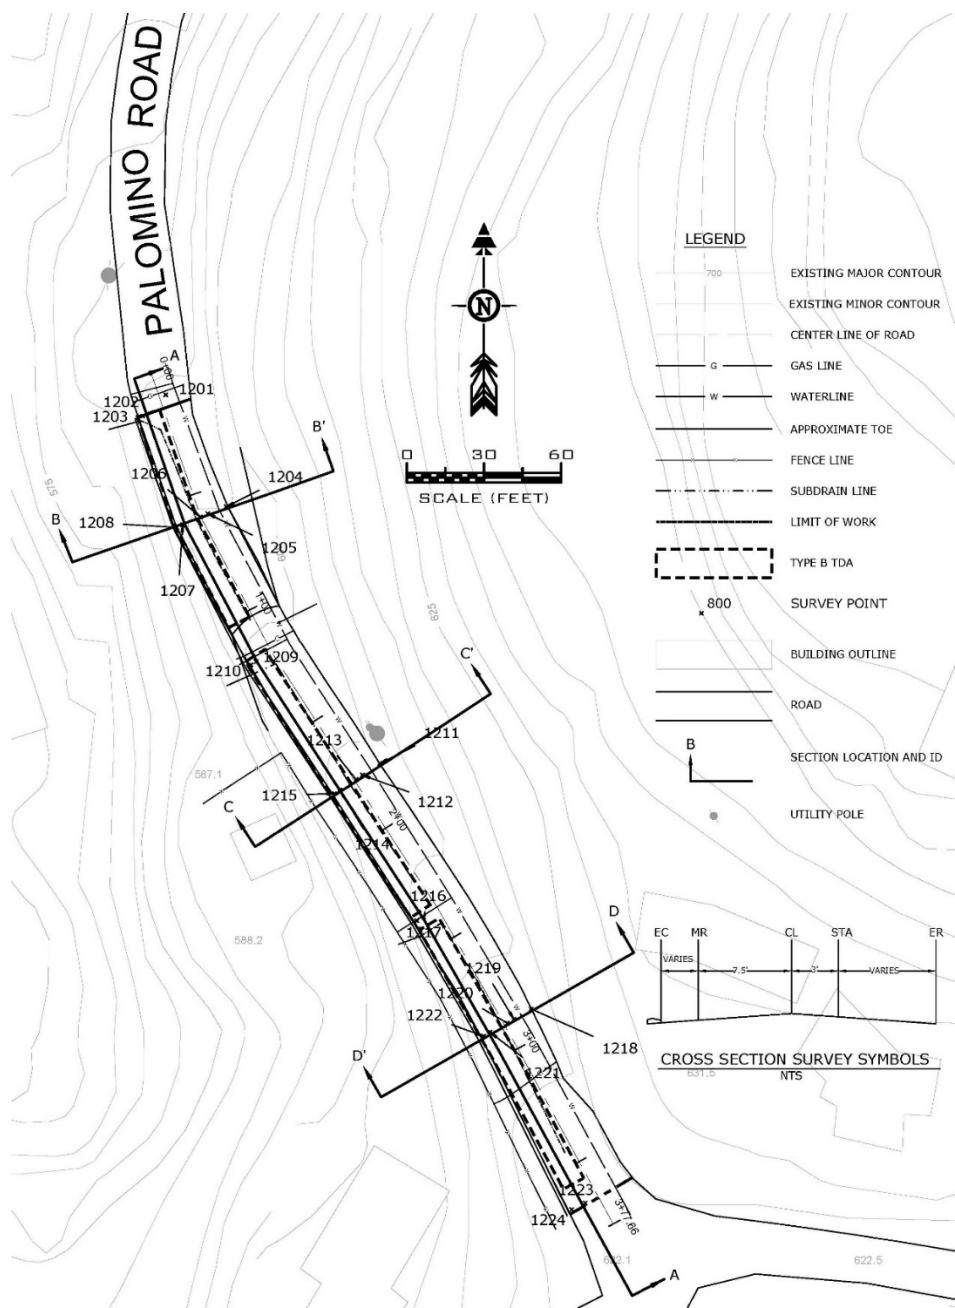
Figure 12. Plan View, Palomino Road

Palomino Road has a distinct construction design and function with respect to the previous three sites discussed. It involved a relatively long, thin, narrow, and shallowly placed TDA till portion in the road prism. Survey data from the TDA repaired section of the roadway indicates variable settlement over the 11-year project life. The maximum settlement of 0.69 feet (8.28 inches) was observed at point 1217 on the northern

outside edge of the project. The average settlement over TDA cross sections is 0.33 feet or 3.96 inches.

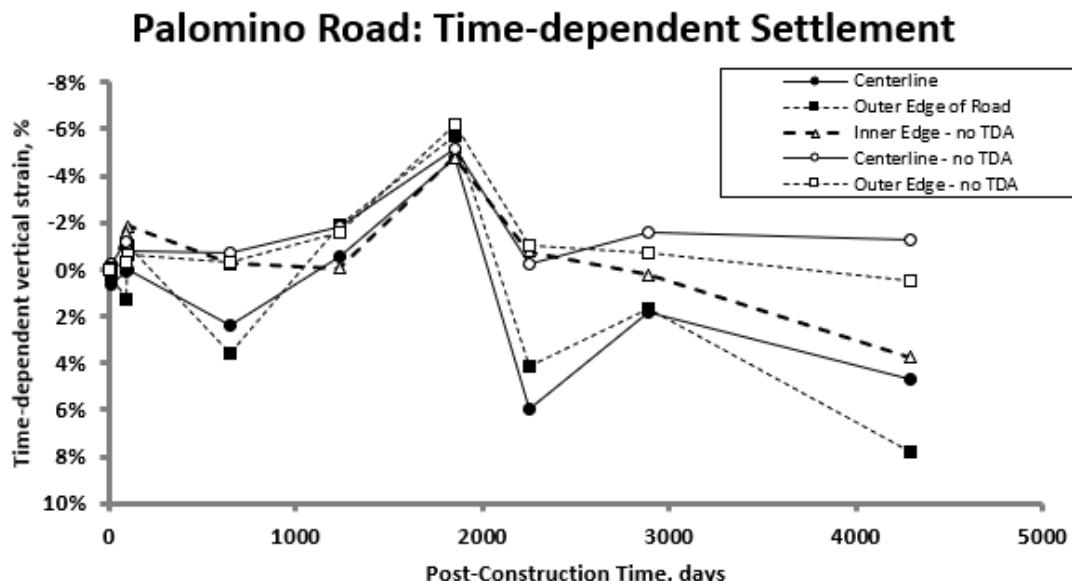
Figure 14. Palomino Road: Time-dependent Settlement for the Inner Edge, Outer Edge, and Centerline Alignments

Given the variable elevations observed in the survey data for Palomino Road during each monitoring event, it suggests that the overall constructed landslide road repair section is experiencing deformation. The observable vertical deformation is likely attributed to the pre-existing subsurface conditions of the site, particularly the presence of highly expansive and poorly consolidated native clay soils documented 32 feet below the ground surface at the Palomino Road repair site.

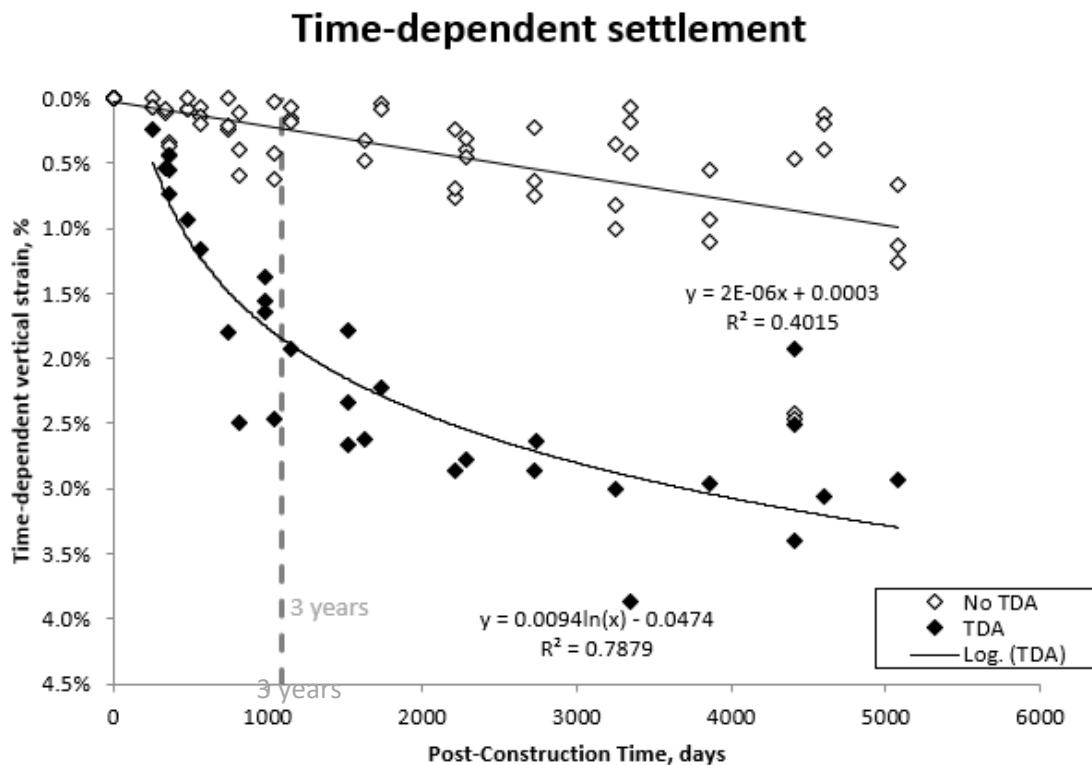
Figure 15. Time-dependent Settlement (combined data from Marina Drive, Geysers Road and Sonoma Mountain Road)

The curve relationship depicted in Figure 15 is based on empirical field data gathered from three different sites: Marina Drive, Geysers Road, and Sonoma Mountain Road, spanning over a period of 14+ years. As expected, areas without TDA installation exhibited lower settlement rates compared to those with TDA, displaying a relatively constant and linear slope over time.

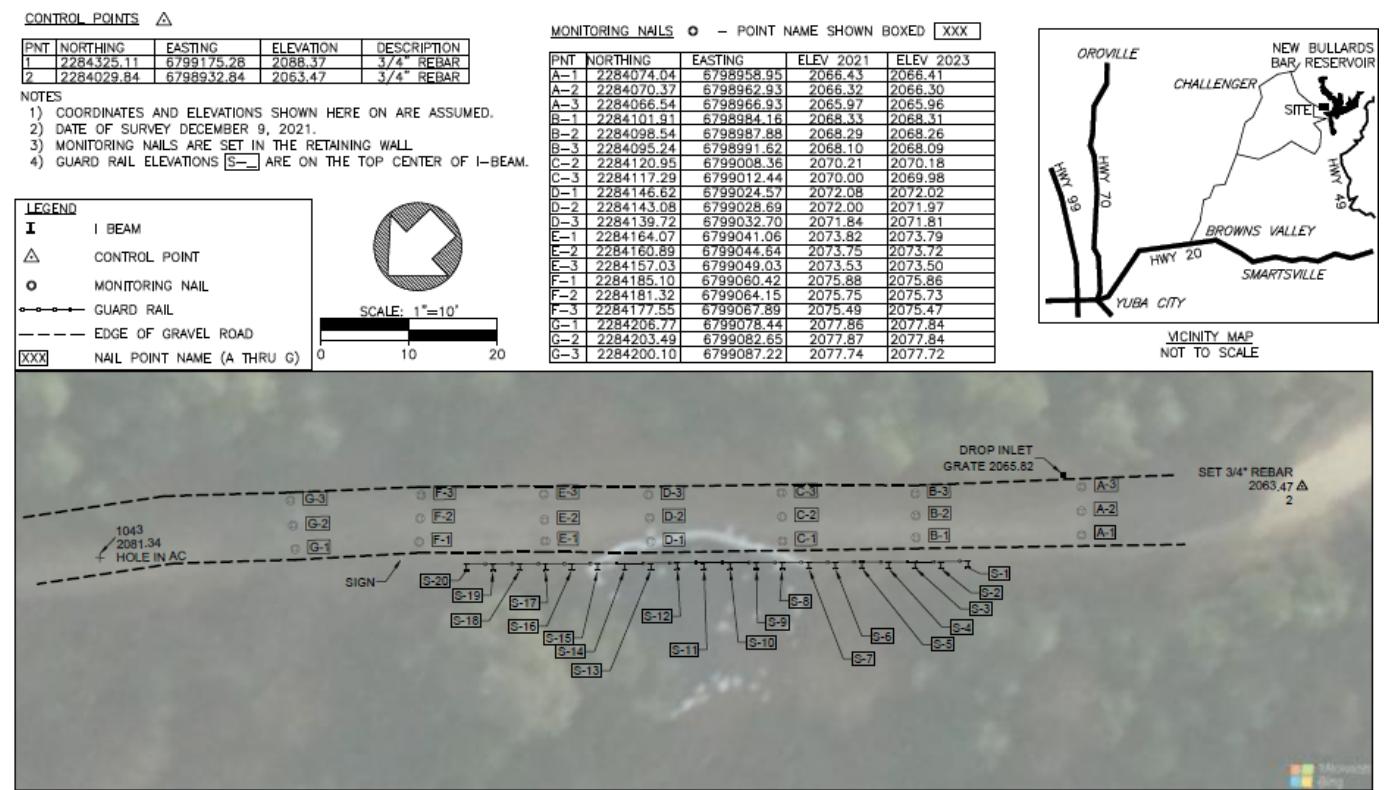
Figure 17. Moran Road Monitoring Points

To date there have been two survey events conducted, and the data from these events is presented in Figure 17, the plan view site drawing. The differences observed between the reflected road surface and pile wall points fall within the survey accuracy/tolerance of 0.05 feet, thereby reflecting zero changes in elevation and northing and easting.

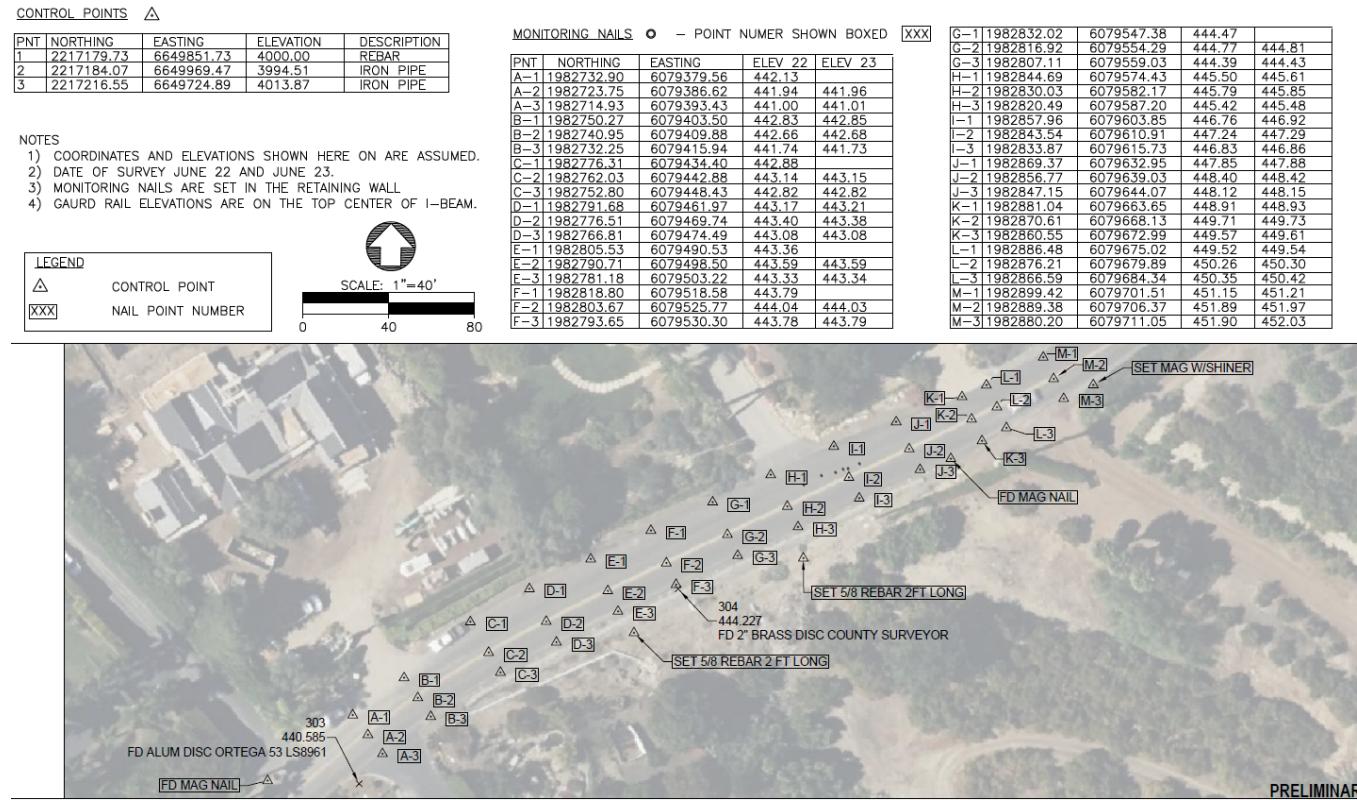
Figure 18. Ortega Ridge Road Monitoring Points

To date, there have been two survey events conducted, and the data from these events is presented in Figure 18, the plan view site drawing. The differences observed between the reflected road surface and welded wire wall rebar points fall within the survey accuracy/tolerance of 0.05 feet, thereby reflecting zero changes in elevation or northing or easting.

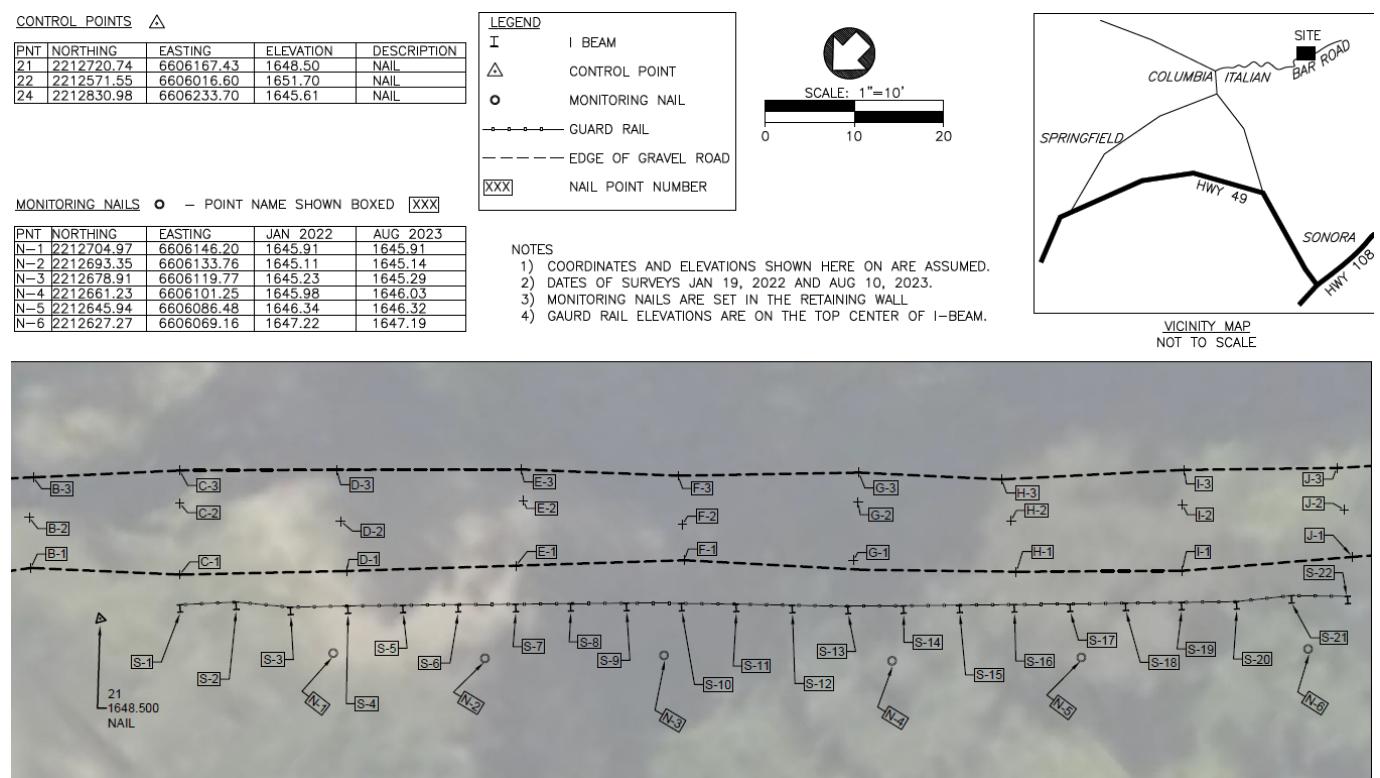
Figure 19. Italian Bar Road Monitoring Points

To date, there have been two survey events conducted, and the data from these events is presented on the plan view site drawing in Figure 19. Surface movement between the events is calculated in Table 3. The differences observed between the reflected road surface, guardrail I-beams, and welded wire wall points fall within the survey accuracy/tolerance of 0.05ft, thereby reflecting zero changes in elevation or northing or easting.
