Department of Resources Recycling and Recovery

Antelope Valley Site Visit: November 17 & 18, 2024

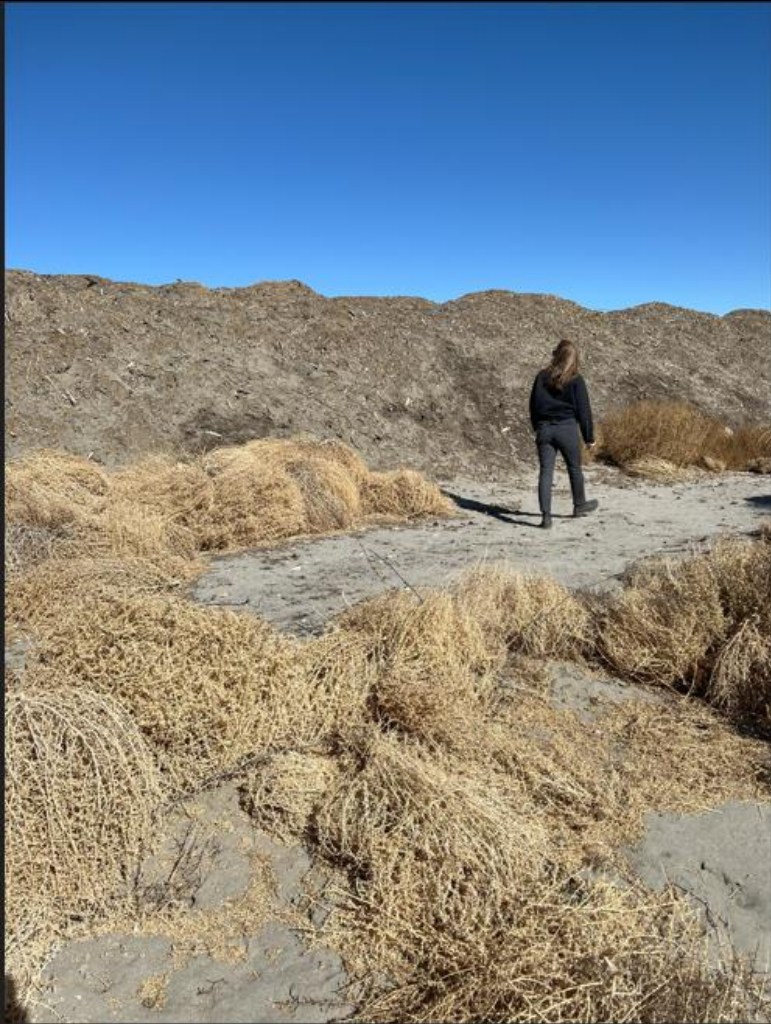
| DBA / Location Name: | Circle Green |

| <b>View of:</b> | Berm surrounding property approximately 5-6 feet high consisting of mulch with sand. |

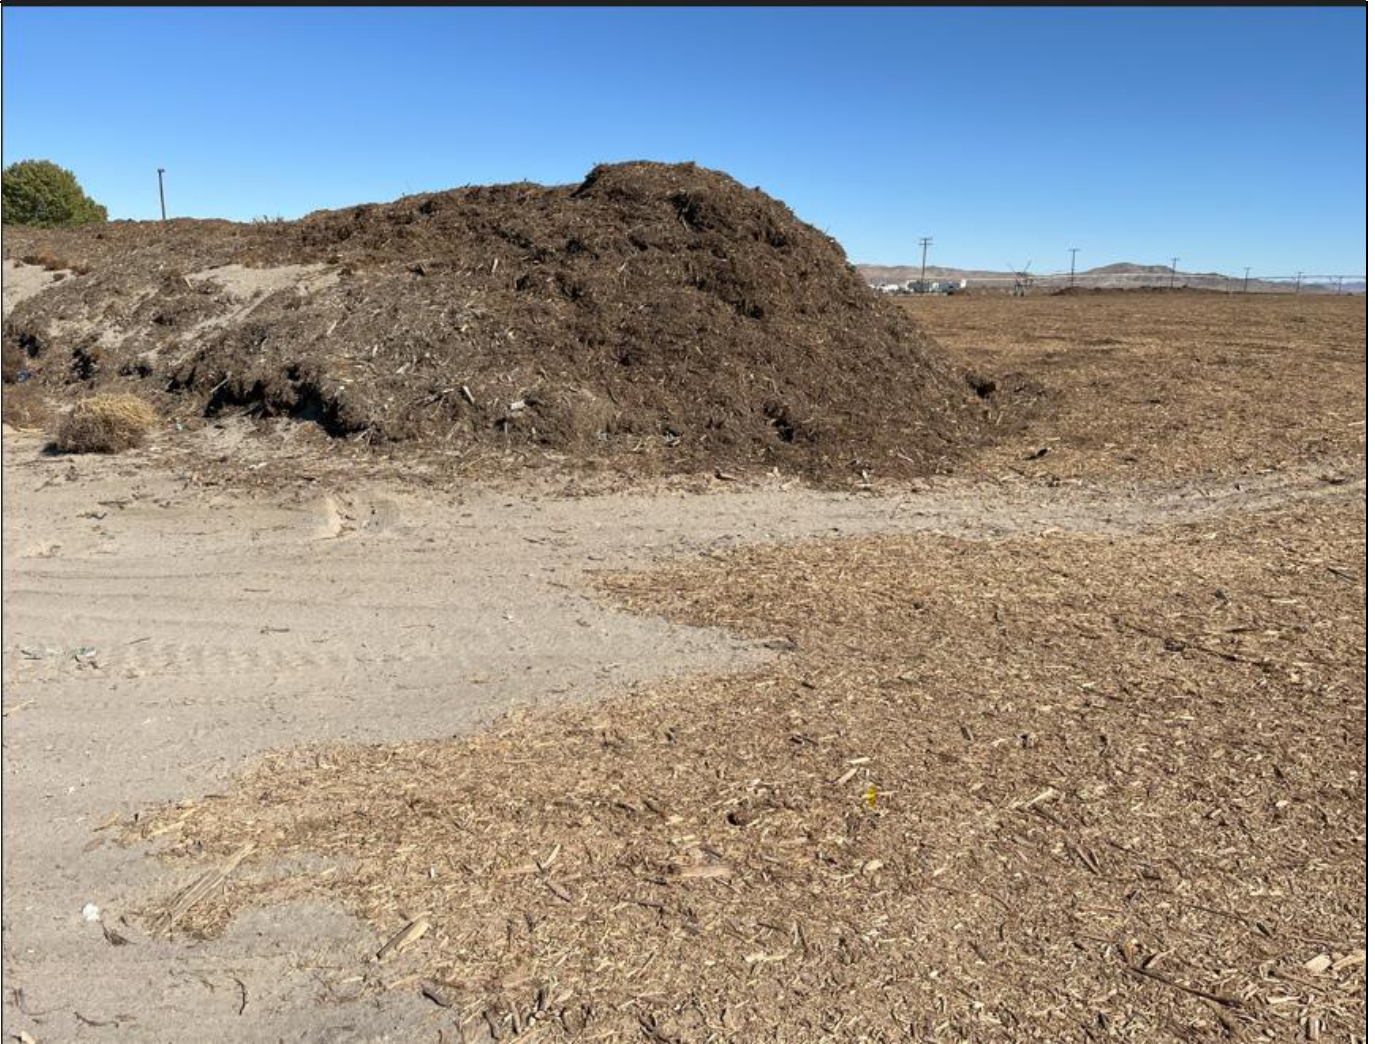
| DBA / Location Name: | Water District |

Berm noting fine sand and mulch surrounding the property. Area surrounded by 5-6 foot berms with the central area with 1-2 feet of fines and mulch.

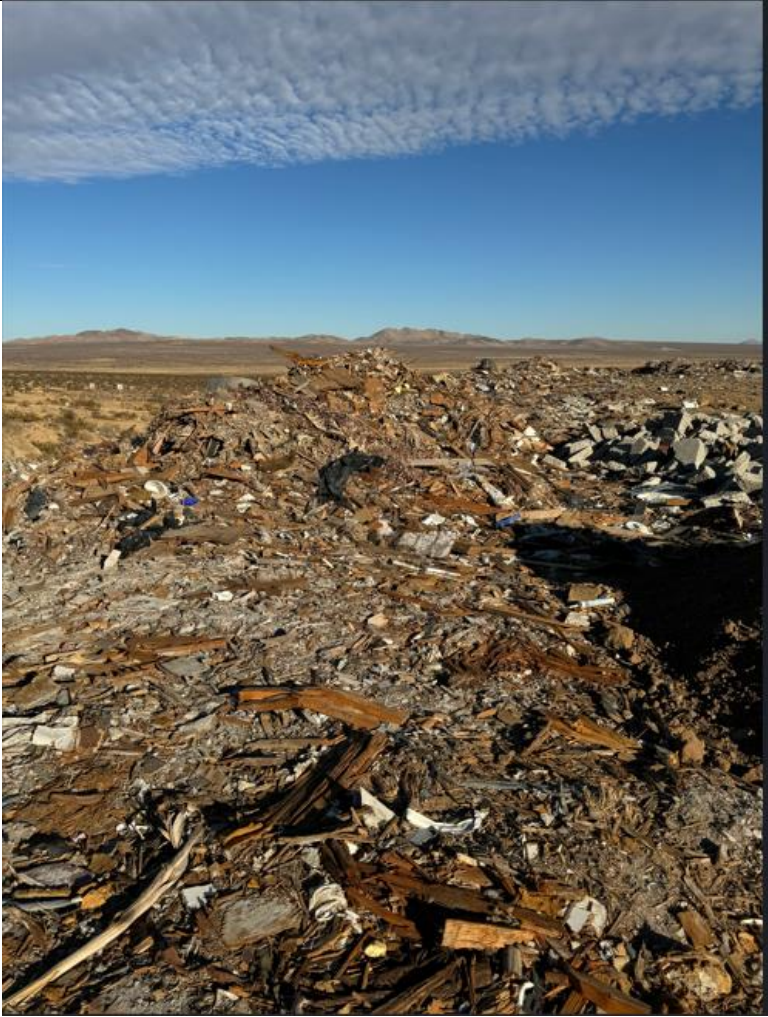
| RECORD INFORMATION & WITNESS DETAILS | |
|---|---|
| DBA / Location Name: | Adobe Mountain |

| View of: | Looking from the valley (noting elevation change to landscape approximately 40 to 50 feet) to the mountains. Materials seen construction and demolition and solid waste. |

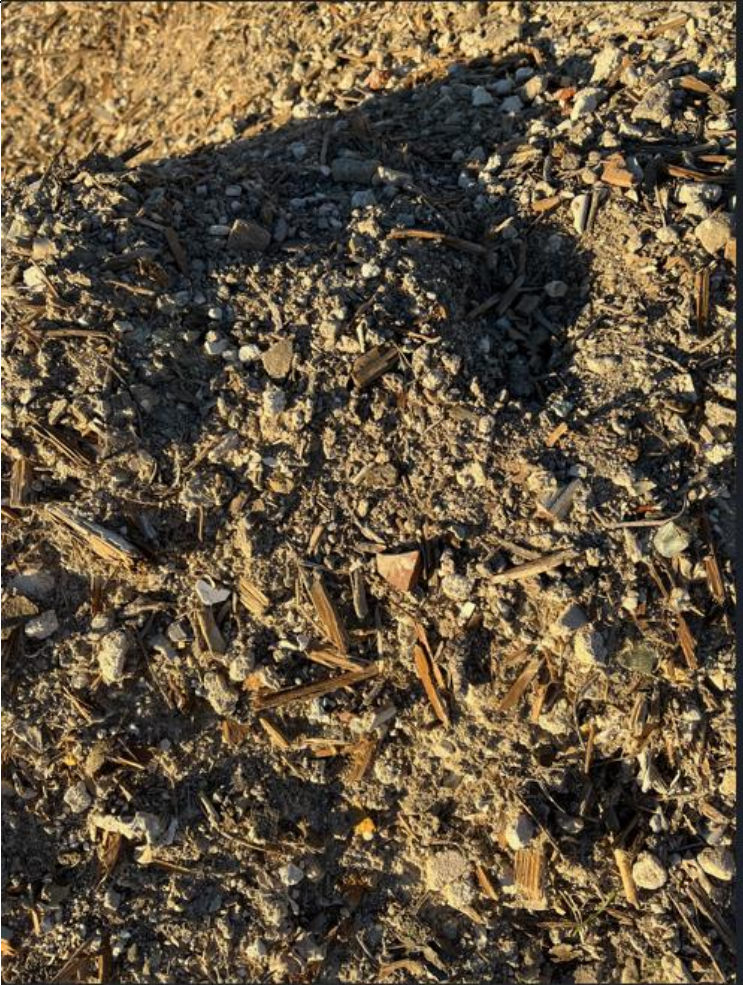
| RECORD INFORMATION & WITNESS DETAILS | |
|---|---|
| DBA / Location Name: | 11-J8 and 250 |

| View of: | Close up of construction and demolition fines. |

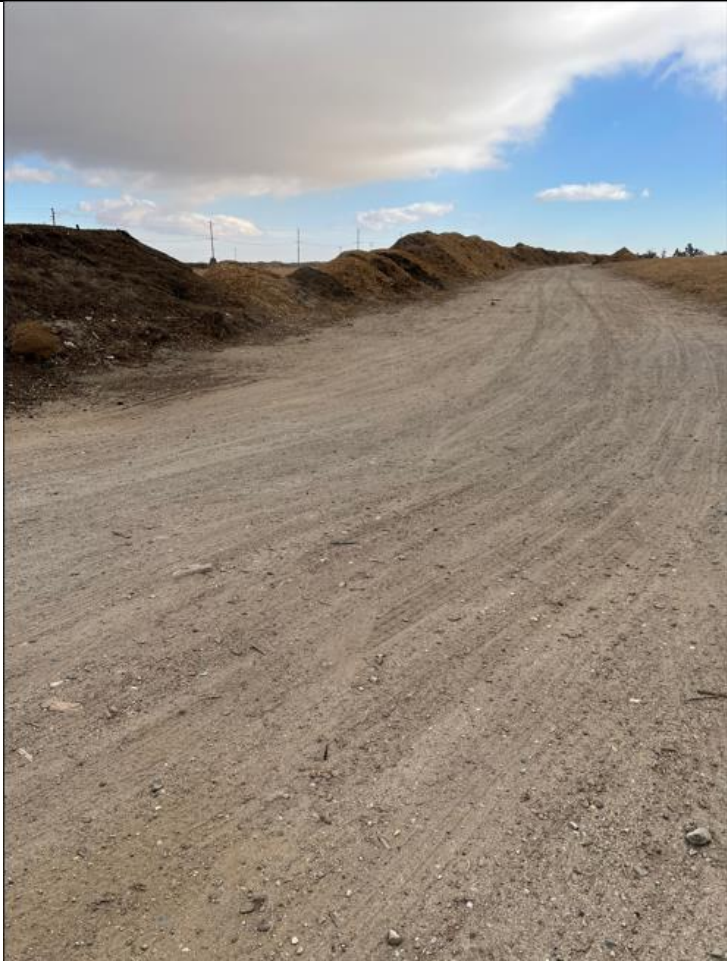
| RECORD INFORMATION & WITNESS DETAILS | |
|---|---|
| DBA / Location Name: | Three Points / Shin |

| View of: | Access road on side of site. Berms consisting of mulch covering MRF fines. |
