Contribution of Leachate from Rubberized Hot Mix Asphalt to Zinc Loading in Roadway Stormwater Runoff

Anticipated Publication Date: May 2021

Produced Under Contract By: Brad A. Finney, Eileen M. Cashman, and Peter A. Duin, Environmental Resources Engineering, Humboldt State University, Arcata, CA

Publication # DRRR-2021-1700

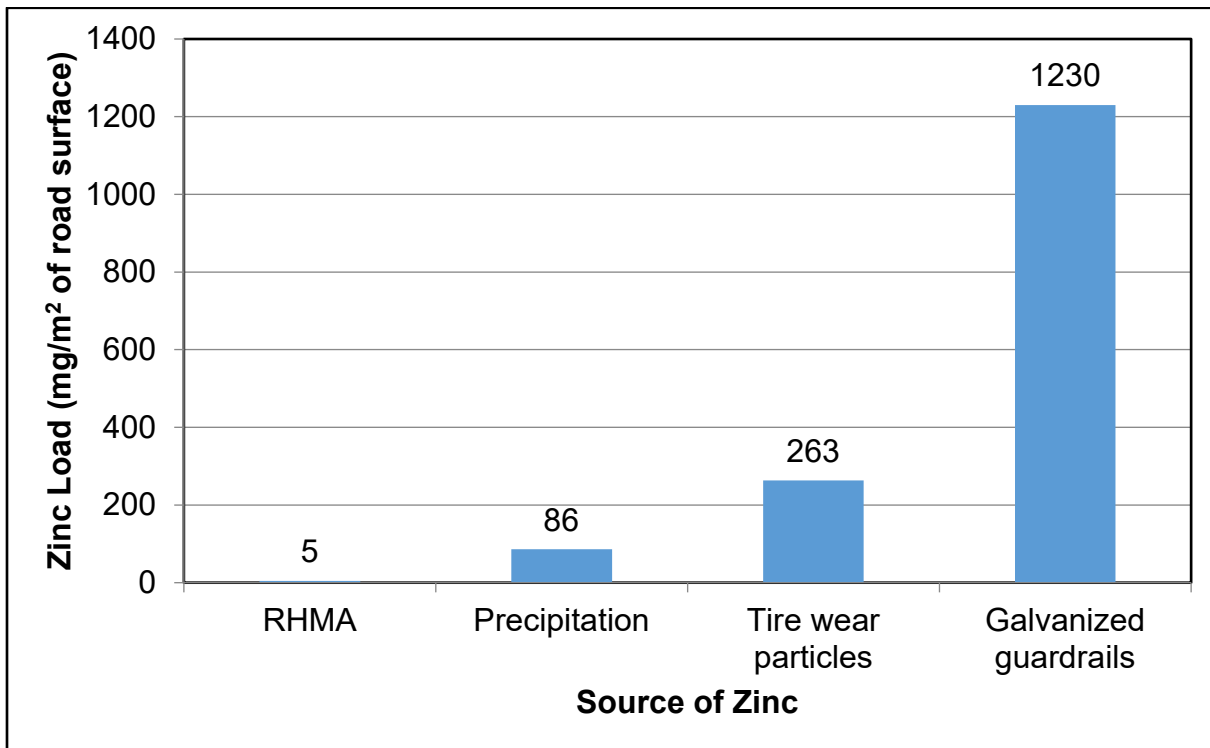
Figure 1: Comparison of zinc load to stormwater runoff off a 20-meter-wide roadway from various sources over a 10-year period. Assumptions for these estimates are based on literature, research analysis, and data collected from Eureka. (Reference Appendix B, Figure 1 Table)

wide, annual average daily traffic (AADT) of 5,000 vehicles, and assuming that 10 percent of the zinc contained in tire wear particles ultimately contributes to zinc in roadway stormwater runoff, tire wear particles would account for approximately 263 mg zinc/m² over a 10-year period. Based on an average observed precipitation zinc concentration of 8 µg/l and the average annual rainfall in Eureka, the wet deposition of zinc on the pavement due to precipitation would be 86 mg zinc/m² over the 10-year pavement life. Finally, using standardized specifications for a Type I galvanized guardrail, the equivalent zinc loading from guardrails along both edges of the roadway would be 1,230 mg/m² over a 10-year period (Figure 1).

The estimated rates for the contribution of various sources of zinc in roadway runoff shown in Figure 1 are subject to uncertainty due to a number of factors. In addition to the impacts of field conditions that were not replicated in the lab (UV degradation, vehicle impaction etc.), the leaching rate from RHMA is dependent on the degree of previous exposure that the asphalt has had to water and the duration of runoff conditions during the period of interest. In this analysis, the assumption was that there were 240 days of runoff conditions (wet road surface) acting on new RHMA pavement over a 10-year period. At a site with a lower mean annual precipitation rate, the rate of zinc loss per precipitation event would be somewhat higher, but with fewer days of runoff the end result would be a lower total mass of zinc loss from the pavement over the 10-year period.

the road surface. The assumed values were comparatively conservative, so while parameter uncertainties and site-specific circumstances could change the magnitude of the estimates provided in Figure 1, it is unlikely that the general outcome of the comparison would change. Given a 50-time difference between the relative contribution of leaching from RHMA and tire wear particles under the stated conditions, it is reasonable to conclude that the use of RHMA is not a major factor in the concentration of zinc in roadway stormwater runoff with the possible exception of the first few runoff events on new pavement. A study capturing the first few runoff events from new RHMA pavement would help to fully understand the extent of the initial zinc loading from new RHMA pavement under field conditions.

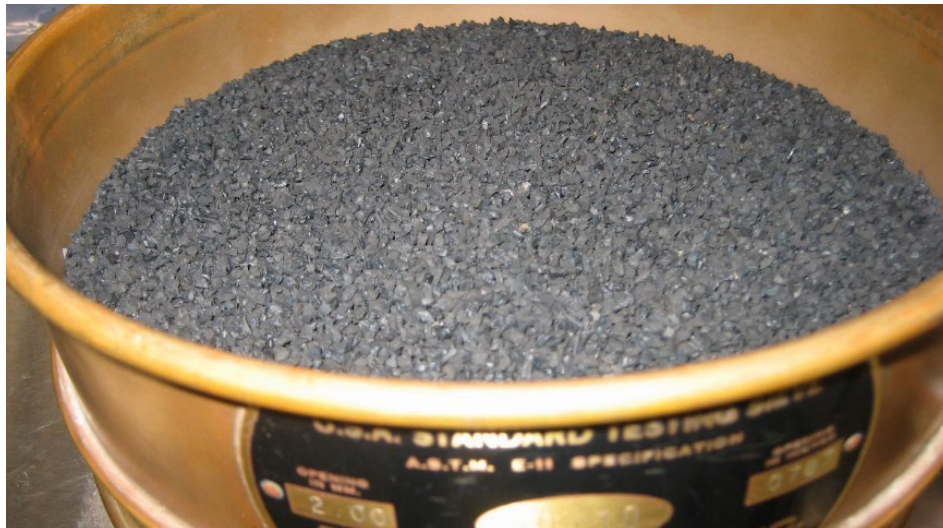
Figure 1: A representative sample of passenger tire crumb rubber that is less than 2 micrometers in diameter.

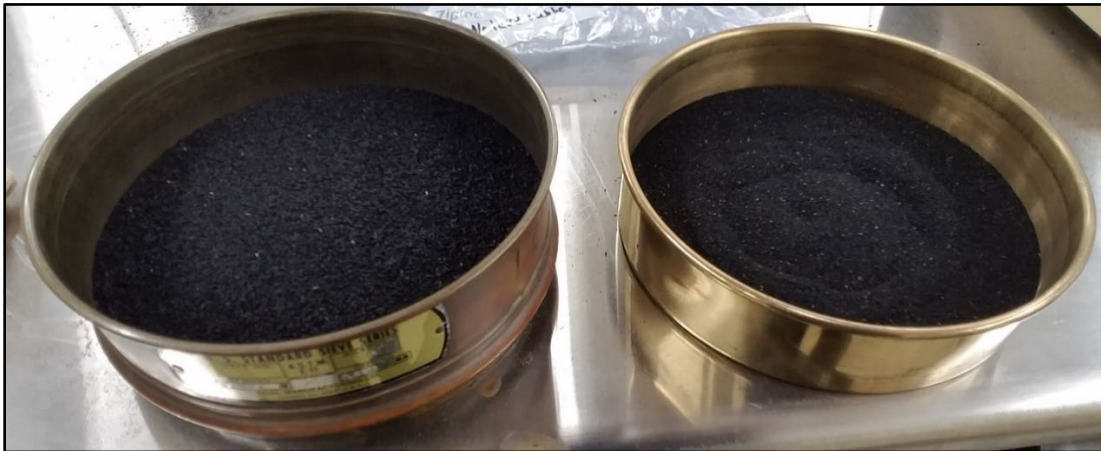
Figure 2: Two size classes of passenger tire crumb rubber were selected as greater than 0.5 mm (large, on left) and less than 0.5 mm (small, on right).

Ten samples were created for each size class (small and large) for each of the two types of rubber (passenger and truck). This resulted in 10 small passenger tire samples (PS), 10 large passenger tire samples (PL), 10 small truck tire samples (TS), and 10 large truck tire samples (TL). Each sample consisted of three grams of tire crumb rubber, submerged in 240 milliliters of distilled water and placed in small plastic bottles.

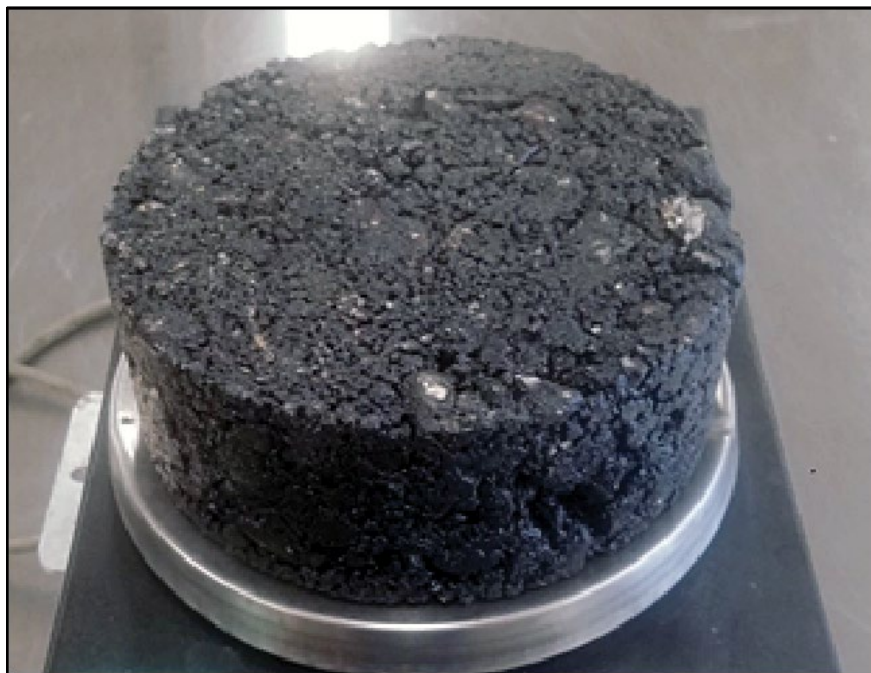
Figure 3: A representative core used in the pavement batch leaching experiments.

Each core was placed into a covered glass jar and submerged with a known volume of distilled water. The contents of the jars were gently stirred prior to taking a

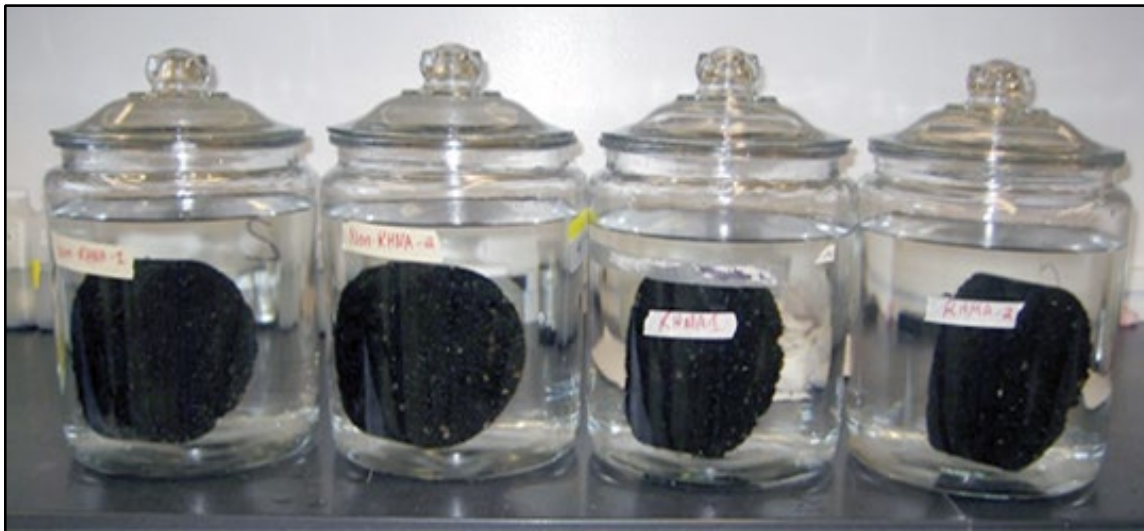
Figure 4: Four identical RHMA pavement cores were each placed in distilled water to determine the zinc leaching rate over time.

Based on previous experiments with TDA, a reduction in the rate of zinc leaching from the asphalt over time was anticipated. The second pavement experiment was designed to determine whether the leaching rate of zinc was dependent on the age of the asphalt, or whether aging might at least temporarily increase the leaching rate. Four identical RHMA cores (RHMA-1, RHMA-2, RHMA-3, and RHMA-4) were allowed to soak for 63 days (Figure 4). Cores RHMA-1 and RHMA-3 were then removed from their jars and subjected to the AASHTO R-30 long term mixture conditioning procedure, which is used to simulate the effect of HMA aging that occurs over the service life of a pavement (AASHTO 2019). The procedure requires that the core samples be placed in an oven at 185 degrees F for 120 hours, followed by a cooling period of 24 hours. After the cores were cool, they were placed back into their soaking jars and leachate samples were collected over the following 29 days and analyzed for total zinc content. This same conditioning procedure was also applied to core RHMA-A from the first experiment that had been soaking for 240 days.

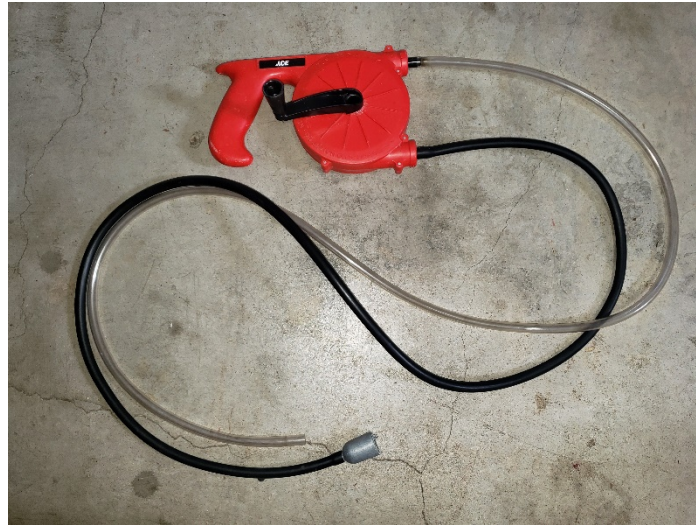
Figure 7: The rotary hand pump used to collect stormwater runoff samples from pavement.

metals such as guardrails. Samples were collected from the pavement with a hand-operated rotary pump and bottled on-site (Figure 7).

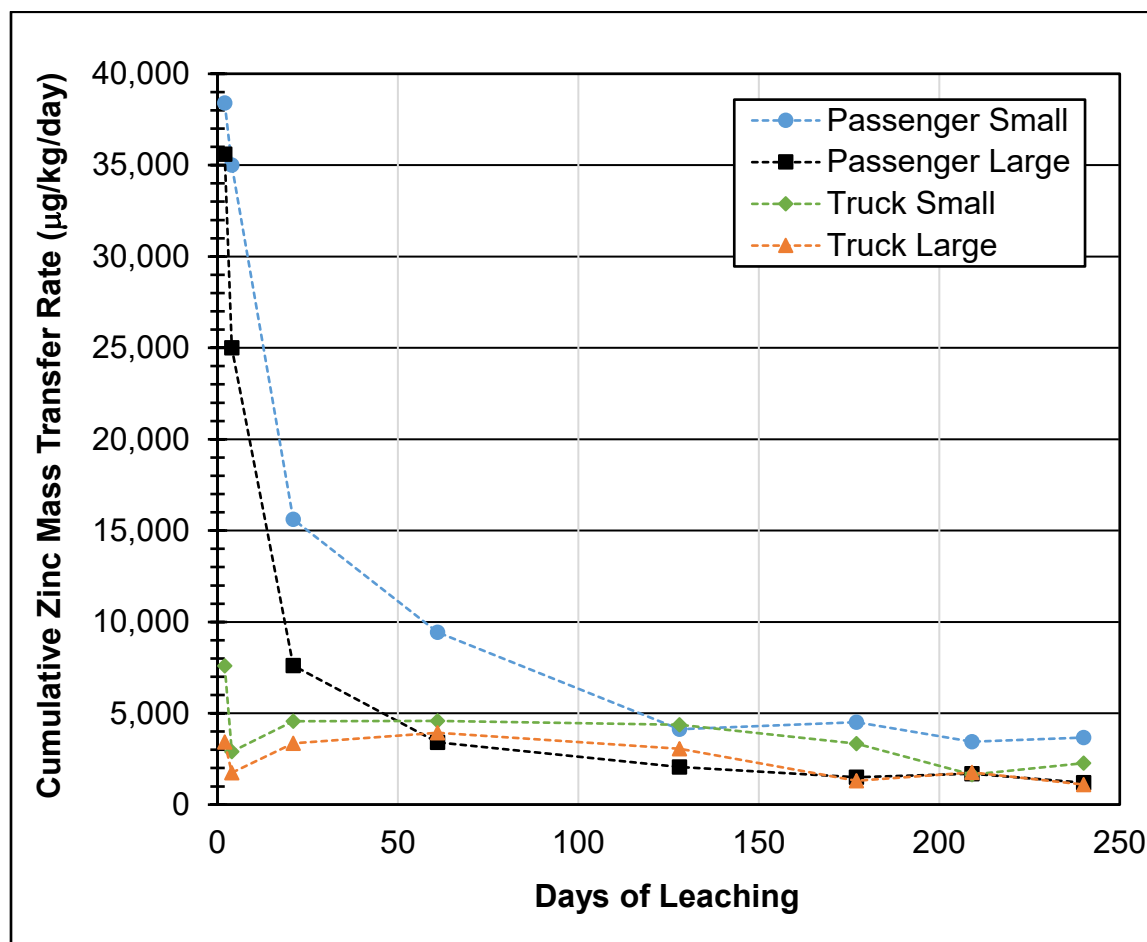
Figure 8: Cumulative zinc mass transfer rate for small- and large-size passenger and truck crumb rubber. (Reference Appendix B, Figure 8 Table)

As expected, the cumulative zinc mass transfer rate from the crumb rubber was found to rapidly decrease from the value found on the first day of sampling (day 2 of leaching) (Figure 8). This decrease in the cumulative mass transfer rate was particularly rapid for the passenger tire crumb, with an order of magnitude reduction during the first 61 days of leaching for the small-diameter crumb rubber and 21 days for the large-diameter crumb rubber. The initial mass transfer rate of zinc from truck crumb rubber was approximately 20 percent of that from the passenger tire crumb rubber. A lower initial rate was anticipated given the lower zinc content of truck tire crumb rubber compared to passenger tire crumb rubber (see Table 13).

The cumulative mass transfer rate of zinc from the submerged passenger and truck tire crumb rubber was higher for small diameter samples compared to the large diameter samples (Figure 8). This was especially true of the passenger tire crumb rubber beginning with the day 21 samples compared to the truck tire crumb rubber. The higher mass transfer rate for the smaller-diameter particles is likely due to the greater surface area to volume (and mass) ratio of those particles compared to the larger-diameter particles. Since rubber is not particularly porous, leaching of zinc from the rubber would occur on the surface of the particles. The small-diameter particles would be expected to have a higher zinc loss rate per unit mass of rubber since there is a larger relative surface area for the leaching to occur.

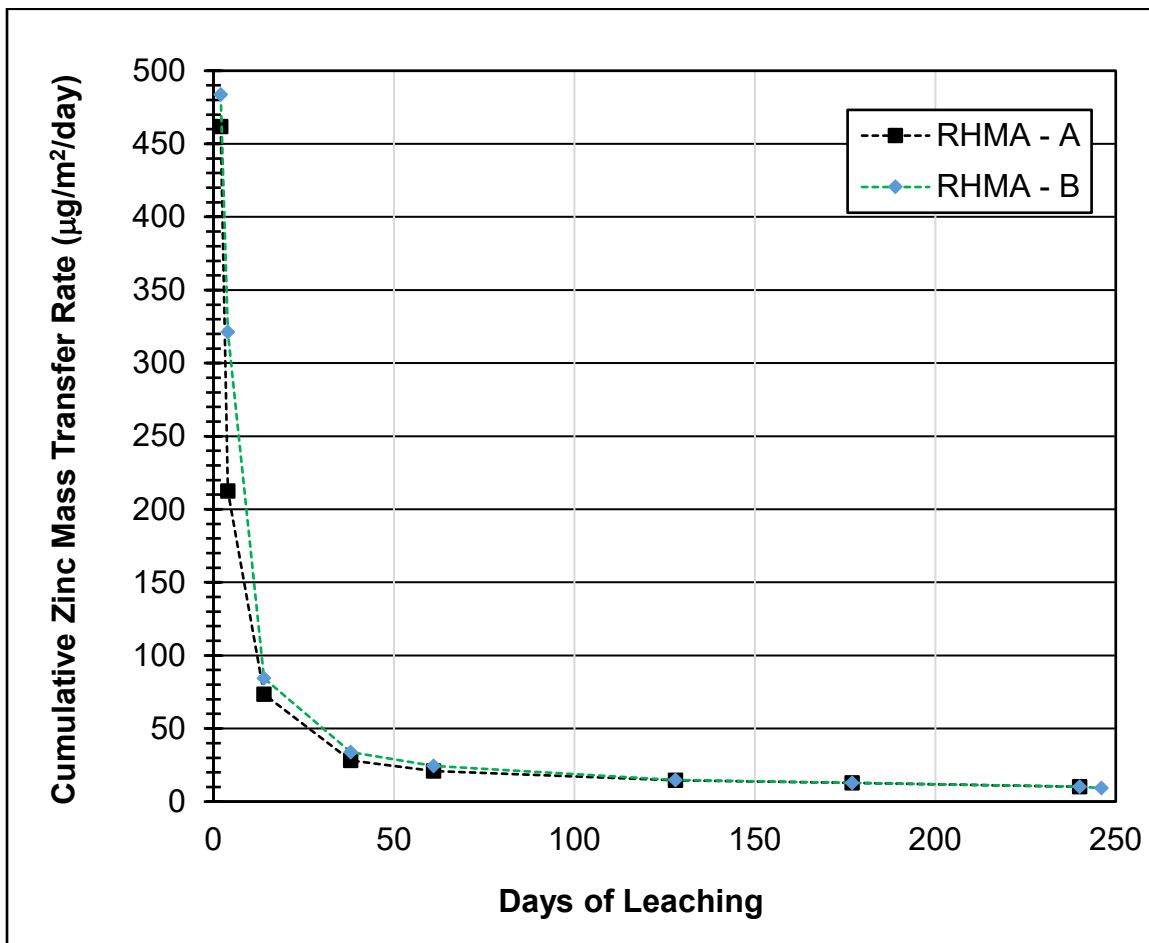
Figure 9: Cumulative zinc mass transfer rates for RHMA cores. (Reference Appendix B, Figure 9 Table)

The concentration of zinc in the leachate from the RHMA cores was above the detection limit for the entire 246-day sampling period. The resulting calculated cumulative zinc mass transfer rate showed a declining trend similar to that observed for crumb rubber (Figure 9). While there were some differences in the cumulative mass transfer rate between the two cores in the first few samples, by day 61 the values for RHMA-A and RHMA-B were nearly identical.

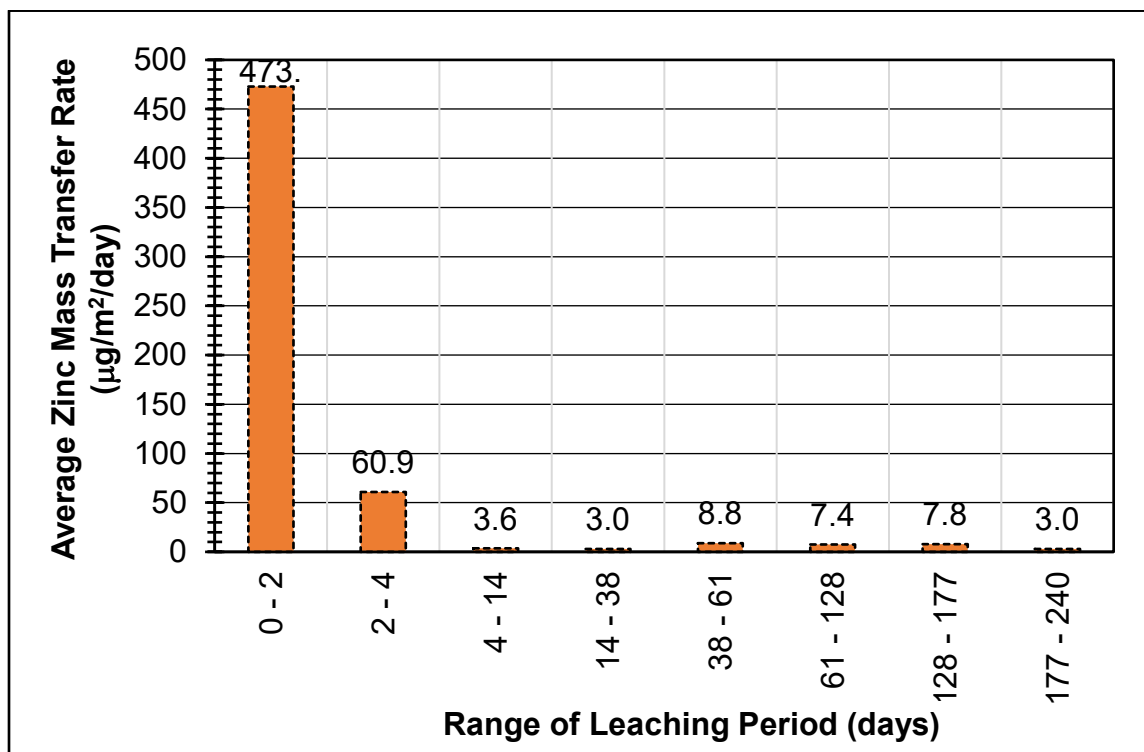
Figure 10: Average zinc mass transfer rate from RHMA cores at different times during the first leaching experiment. (Reference Appendix B, Figure 10 Table)

Since the mass transfer rate is declining over time, and the leaching layer of the RHMA binder is not renewed, the cumulative zinc mass transfer rate is an overestimate of the actual instantaneous rate that would be observed in the field during all but the first few runoff events after the surface was paved. A better estimate of the rate that would be observed at any point in time in the life of the pavement surface can be estimated by dividing the mass of zinc per unit surface area of the RHMA core released during a sample period divided by the length of the sample period. The resulting calculated values indicates that the average zinc mass transfer rate would be less than 10 $\mu\text{g}/\text{m}^2/\text{day}$ for RHMA surfaces that had already experienced at least four days of leaching conditions (Figure 10).

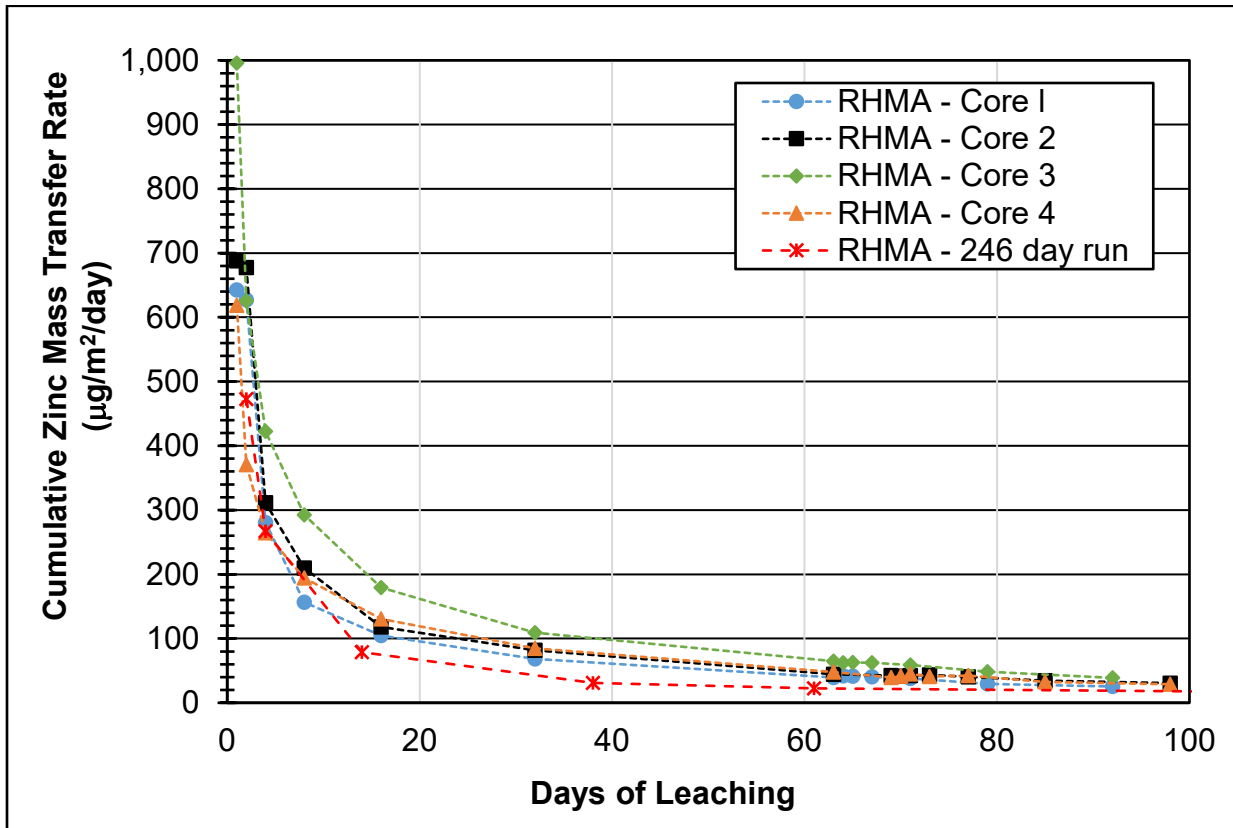
Figure 12: Cumulative zinc mass transfer rates for the four RHMA cores in the second leaching experiment. The results for the average transfer rate from the first experiment are included for comparison. (Reference Appendix B, Figure 12 Table)

The artificial aging of Core 1 and Core 3 does not have any noticeable impact on the zinc leaching rate. No dramatic change in the cumulative zinc mass transfer rate is observed on or after the day 64 sample for those cores (Figure 12), nor is there a notable change in the concentration of the leachate on the first and subsequent samples after the aging (Figure 14). Based on these results, aging and dry season interruptions in wetting of the RHMA from stormwater would not be expected to result in an increased zinc leaching rate during subsequent wet periods over the life of the road surface.

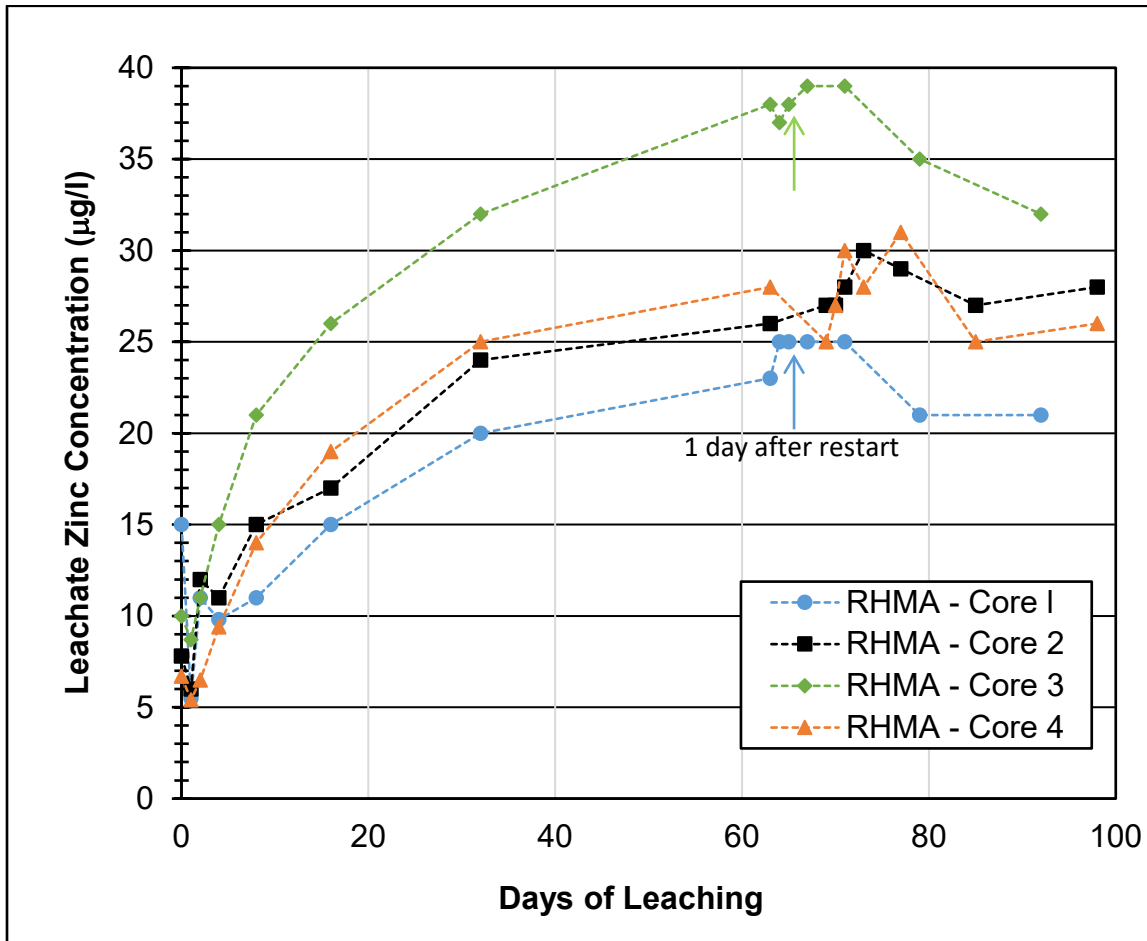
Figure 14: Leachate zinc concentration for all four RHMA cores illustrating little change in leaching behavior in Core 1 and Core 3 after artificial aging. Arrows indicate the sample taken one day after leaching resumed for Core 1 and 3. (Reference Appendix B, Figure 14 Table)

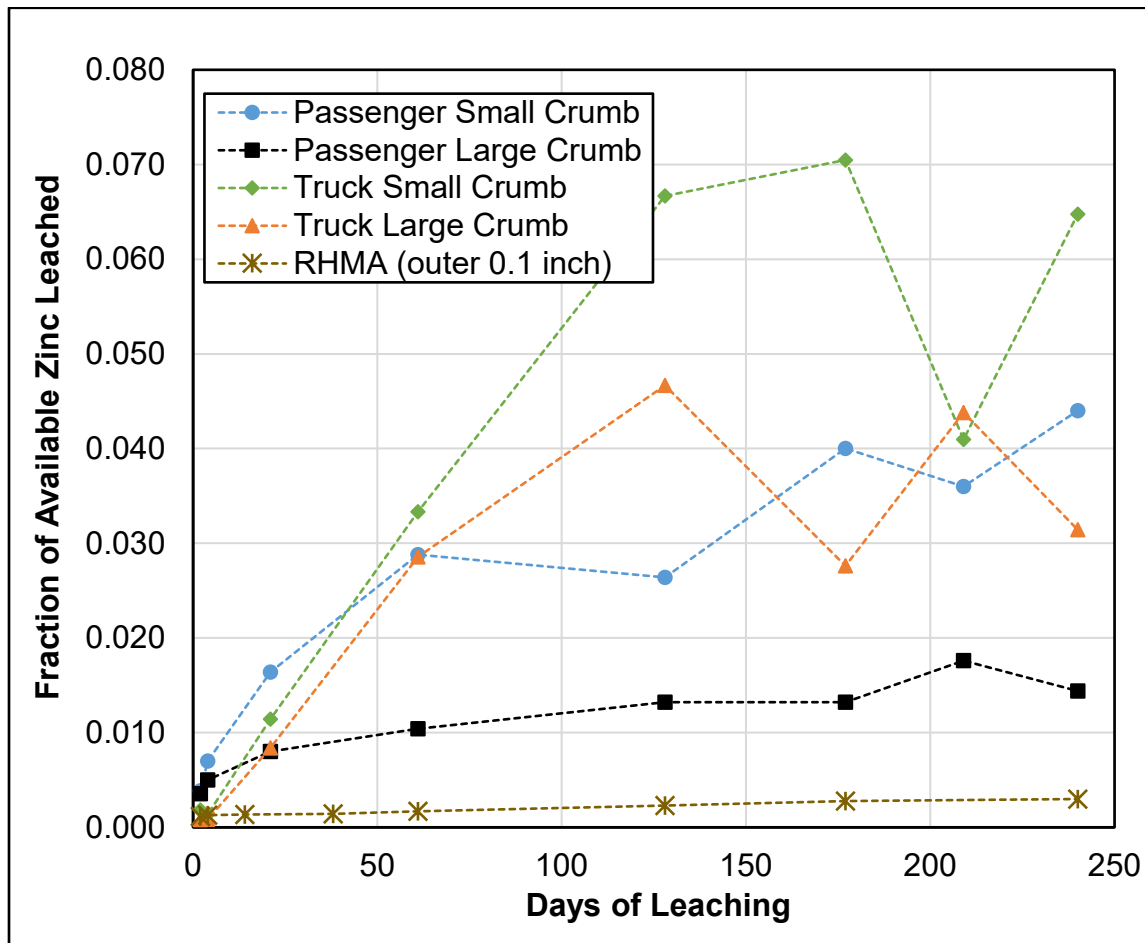
Figure 15: Fraction of zinc contained within crumb rubber and a RHMA core that entered the water column during the leaching experiments. (Reference Appendix B, Figure 15 Table)

When computing the fraction of zinc contained within the RHMA cores that was measured in the water column, it was assumed that only the outer 0.1 inch of the core was available for leaching. After nearly 250 days of being submerged, less than 0.2 percent of the zinc in the outer 0.1 inch of the RHMA cores had entered the water column. This suggests that only a very small fraction of the zinc in RHMA pavement would contribute to zinc loading in stormwater runoff from roadways. Using a linear extrapolation from the sample results, even with continuous submergence, less than 3 percent of the zinc present in the top 0.1 inch layer of RHMA would be leached during the typical 10-year life of a pavement section. The estimated fraction of zinc leached is linearly dependent on the assumed depth of material available for leaching. For example, if the leachable depth was 0.05 inch, then the result would be that less than 6 percent of the zinc present in the top 0.05 inch layer of RHMA would be leached during the typical 10-year life of a pavement section.

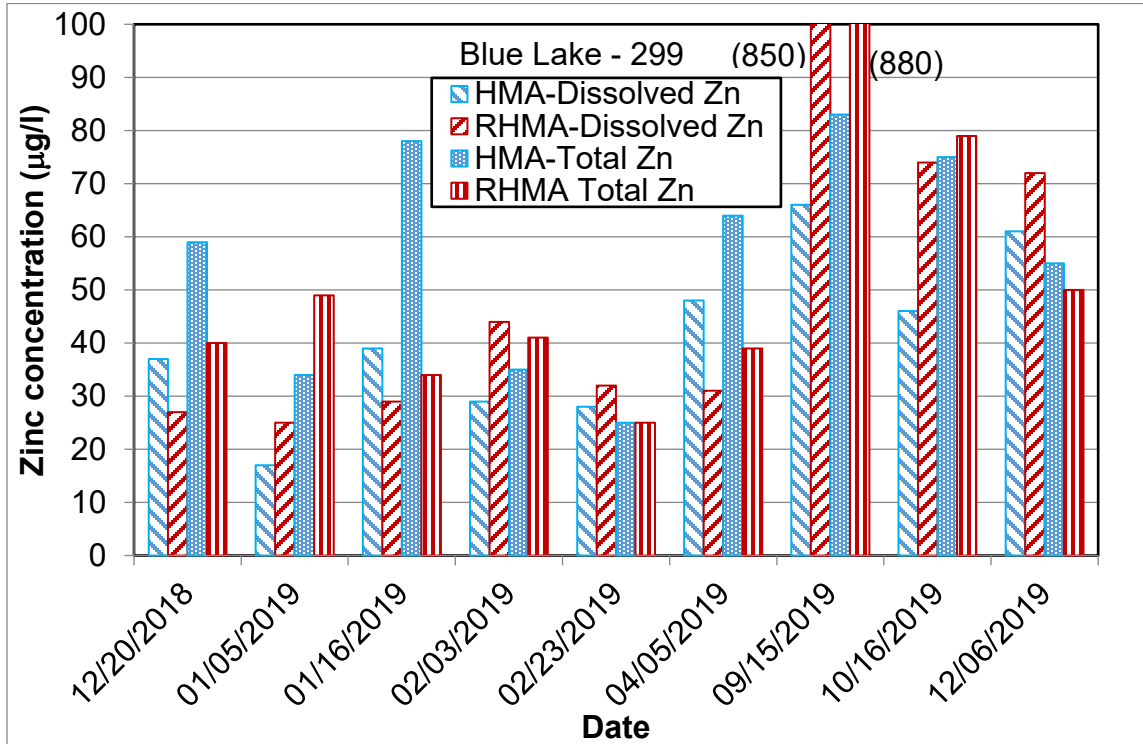
Figure 16: Dissolved and total zinc concentration in stormwater runoff from paired HMA-RHMA pavement at the Blue Lake - 299 location. (Reference Appendix B, Figure 16 Table)

pavement was recorded. This extremely high concentration, along with the matching dissolved zinc concentration of 850 $\mu\text{g/l}$, is almost double that of any other observation from the HSU sites and appears to be a one-off outlier. With the exception of this one event, the concentration from the HMA pavement was higher than from the RHMA pavement when there was a large difference between the zinc concentrations of paired observations.

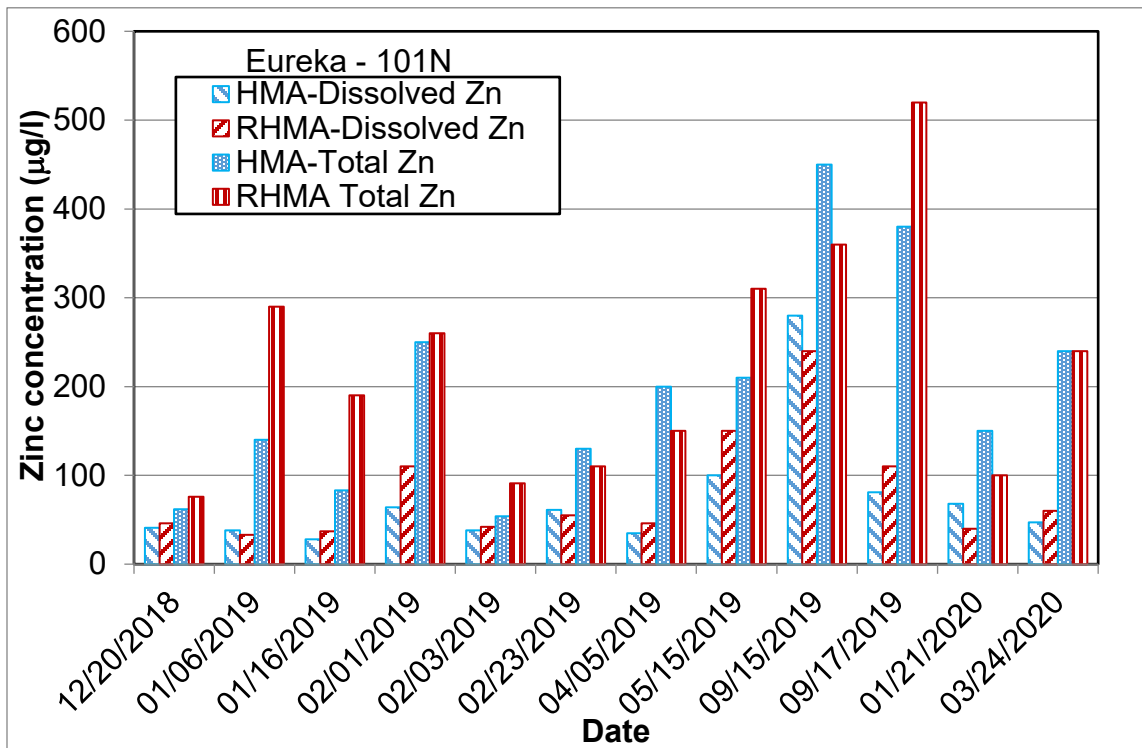
Figure 17: Dissolved and total zinc concentration in stormwater runoff from paired HMA-RHMA pavement at the Eureka - 101N location. (Reference Appendix B, Figure 17 Table)

The difference between the mean total zinc concentrations of the 12 events sampled at the Eureka 101N HMA-RHMA paired sites was smaller than at the Blue Lake 299 site. The mean concentration for total zinc of the RHMA samples was 225 µg/l compared to 196 µg/l for the HMA samples (Table 19). However, the results do not necessarily indicate that runoff from RHMA pavement is generally higher than from HMA pavement. For six of the 12 events sampled, the total zinc concentration was higher in the RHMA sample, for four events it was higher in the HMA sample, and for two events the concentration was approximately the same in the paired HMA-RHMA samples (Figure 17). Perhaps the only trend is that when there is a large difference in the total zinc concentration of runoff between the two pavement types, the RHMA site generally had the higher value. The higher mean for the RHMA samples was due to the three events with differences in total zinc between the RHMA and HMA sample exceeding 100 µg/l.

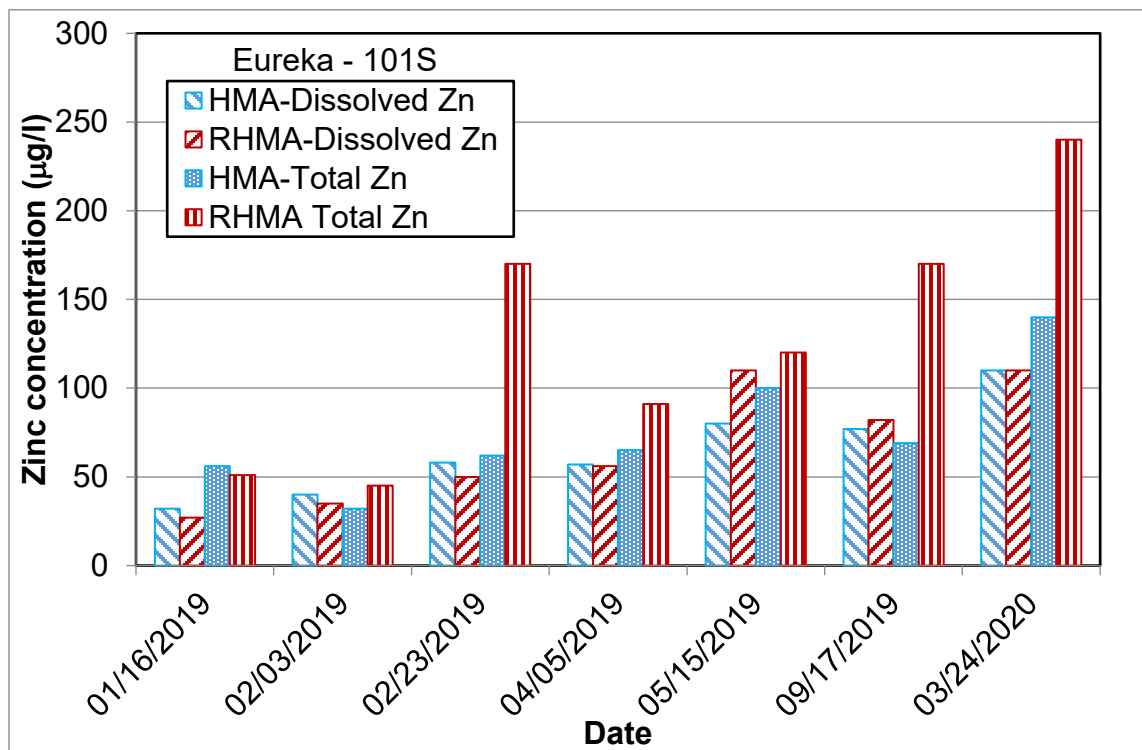
Figure 18: Dissolved and total zinc concentration in stormwater runoff from paired HMA-RHMA pavement at the Eureka – 101S location. (Reference Appendix B, Figure 18 Table)

At the Eureka 101S site, the total zinc concentration in the runoff from the RHMA pavement was nearly always higher than from the paired HMA pavement (Figure 18). The total zinc concentration from the RHMA pavement was higher than the corresponding sample from the HMA for six of the seven total events sampled. The mean concentration of total zinc of the RHMA samples was 127 µg/l compared to 105 µg/l for the HMA samples (Table 19). For three of the seven events, the total zinc concentration from the RHMA site was over 100 µg/l higher than from HMA pavement. However, the same pattern does not hold true for dissolved zinc concentrations where the mean concentration for the HMA samples is higher than the mean concentration for the RHMA samples (74 µg/l compared to 67 µg/l).

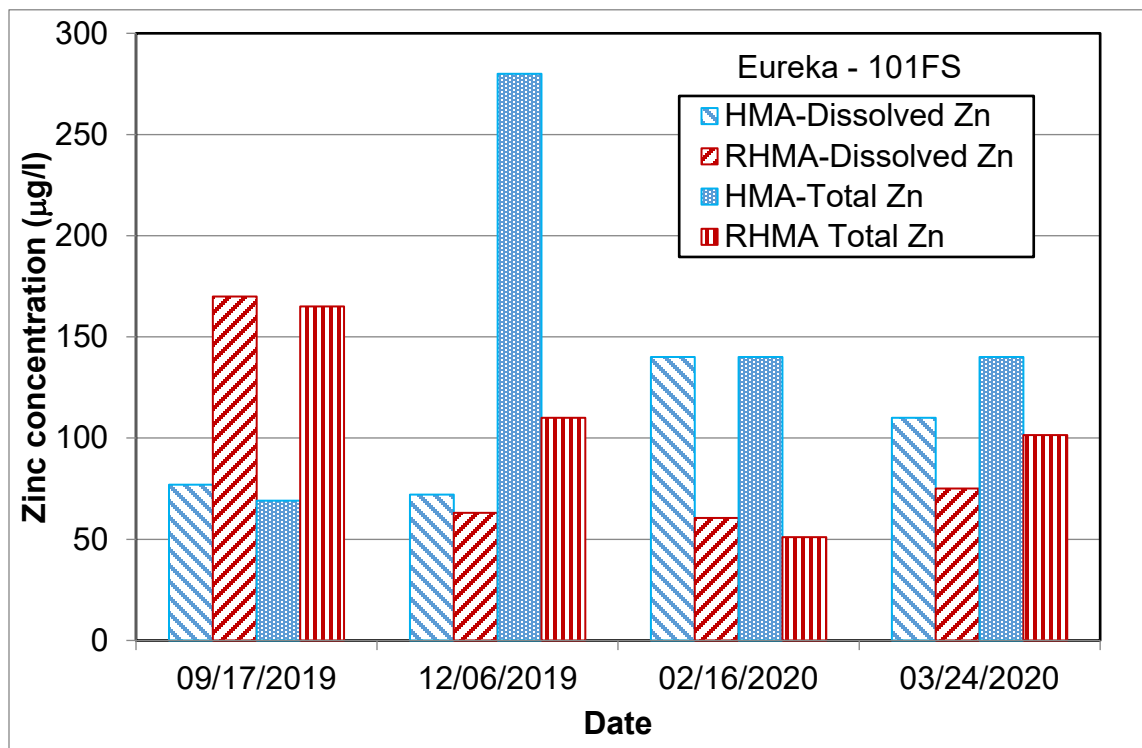
Figure 19: Dissolved and total zinc concentration in stormwater runoff from paired HMA-RHMA pavement at the Eureka – 101FS location. (Reference Appendix B, Figure 19 Table)

The Eureka 101FS site was established to sample from a section of RHMA that had been paved during the summer of 2019. Only four runoff samples were collected from the newly paved RHMA site that could be paired with runoff events from a nearby HMA site. There was some expectation that the zinc concentration from the RHMA samples would be higher than from the HMA site because the laboratory leaching study showed that fresh RHMA does leach zinc. However, this turned out to be true for only the first sampled event, while for the last three events the total zinc concentration was much higher in the runoff from the HMA pavement than from the RHMA pavement (Figure 19). The mean concentration for total zinc of the four RHMA samples was 107 µg/l compared to 157 µg/l for the HMA samples.

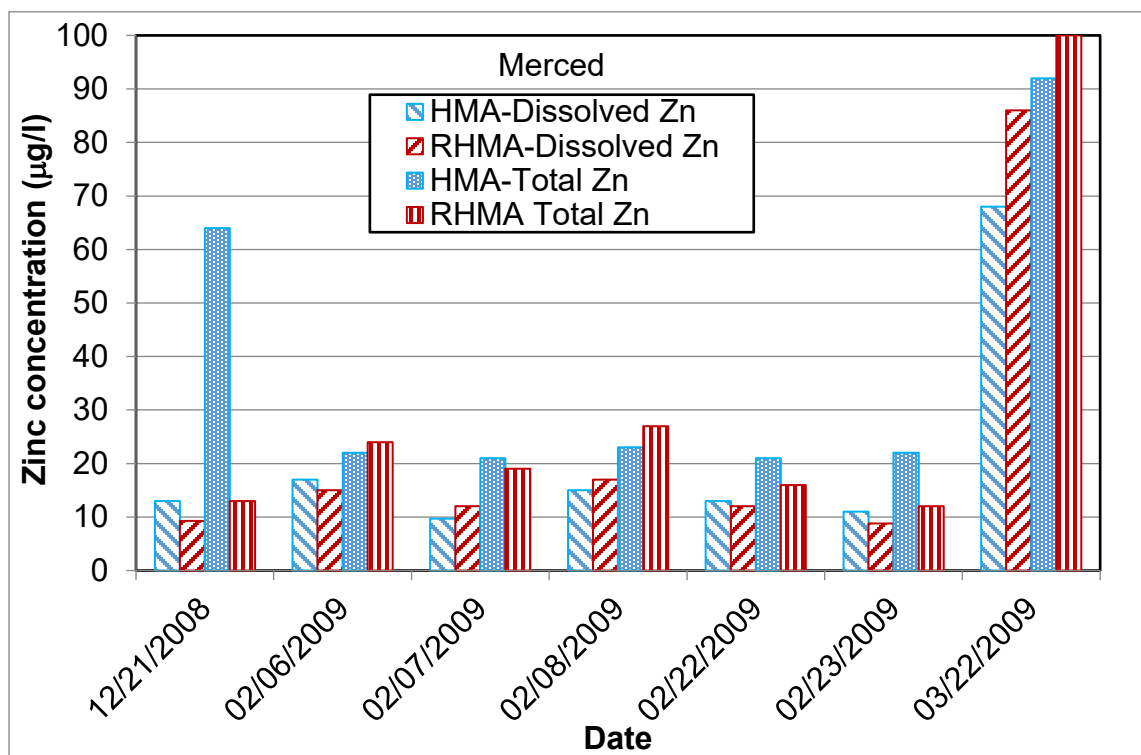
Figure 20: Paired dissolved and total zinc concentrations in runoff from HMA and RHMA pavement in Merced. (Reference Appendix B, Figure 20 Table)

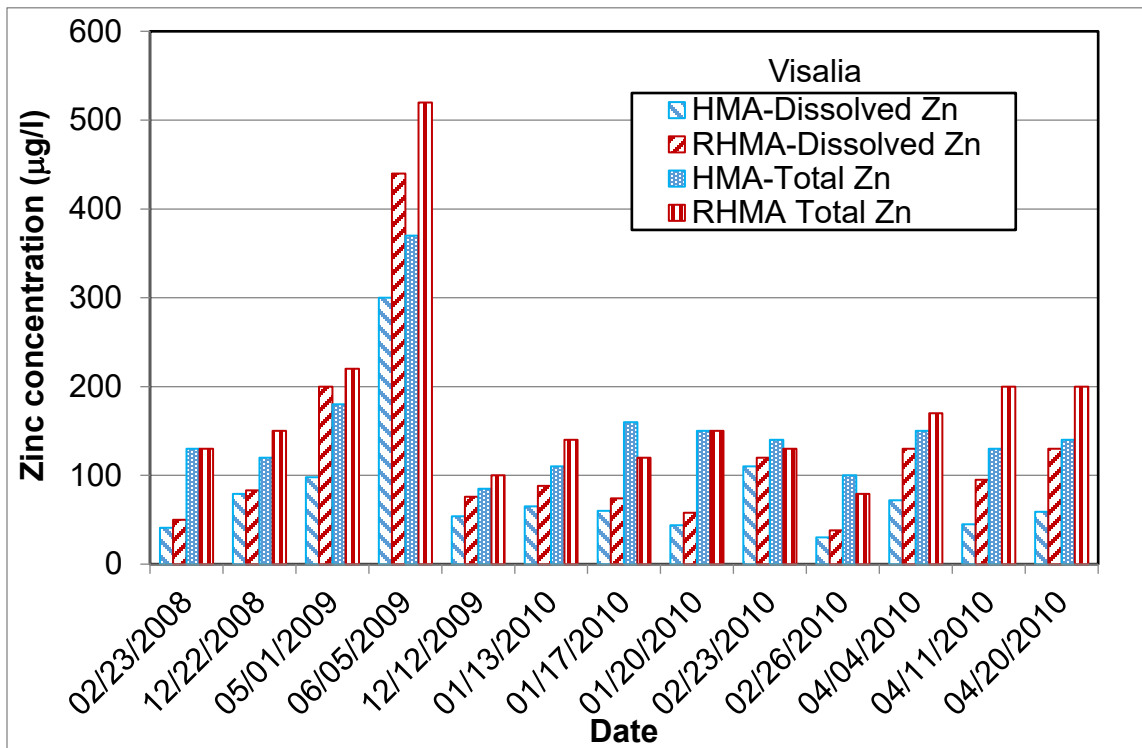
Figure 21: Paired dissolved and total zinc concentrations in runoff from HMA and RHMA pavement in Visalia. (Reference Appendix B, Figure 21 Table)

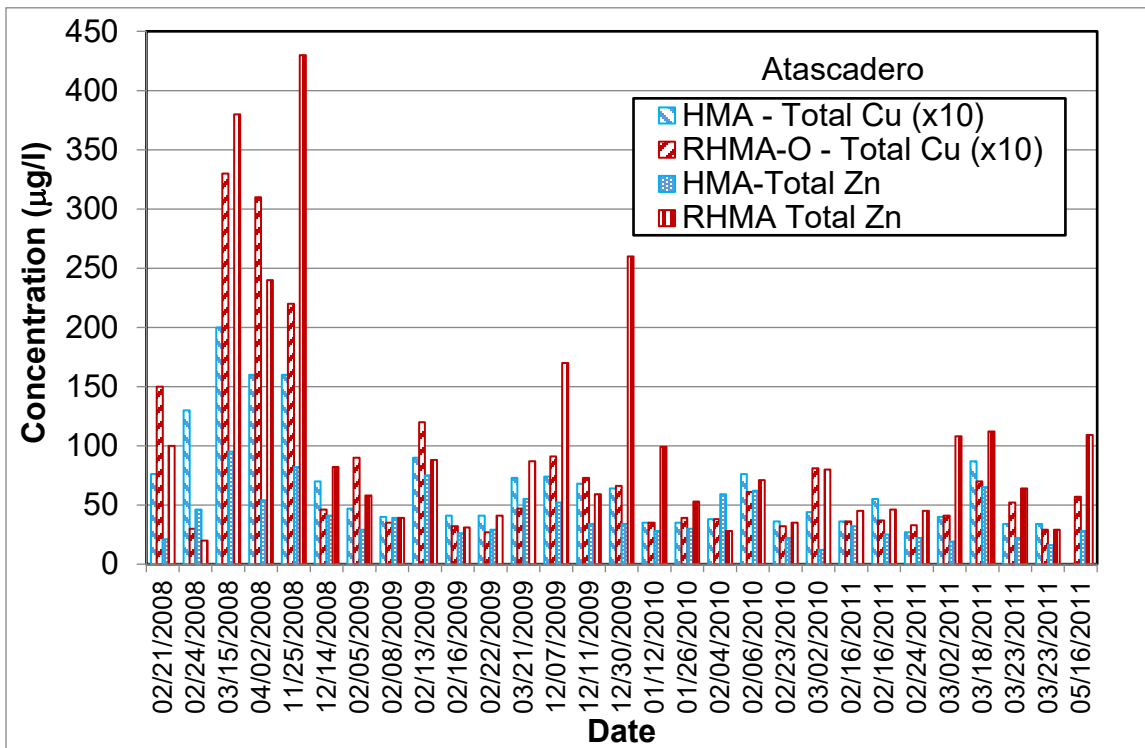
Figure 24: A comparison of total zinc and copper (scaled 10 times) concentration at the Atascadero paired sampling location shows a moderate linear correlation ($r^2=0.65$). (Reference Appendix B, Figure 24 Table)

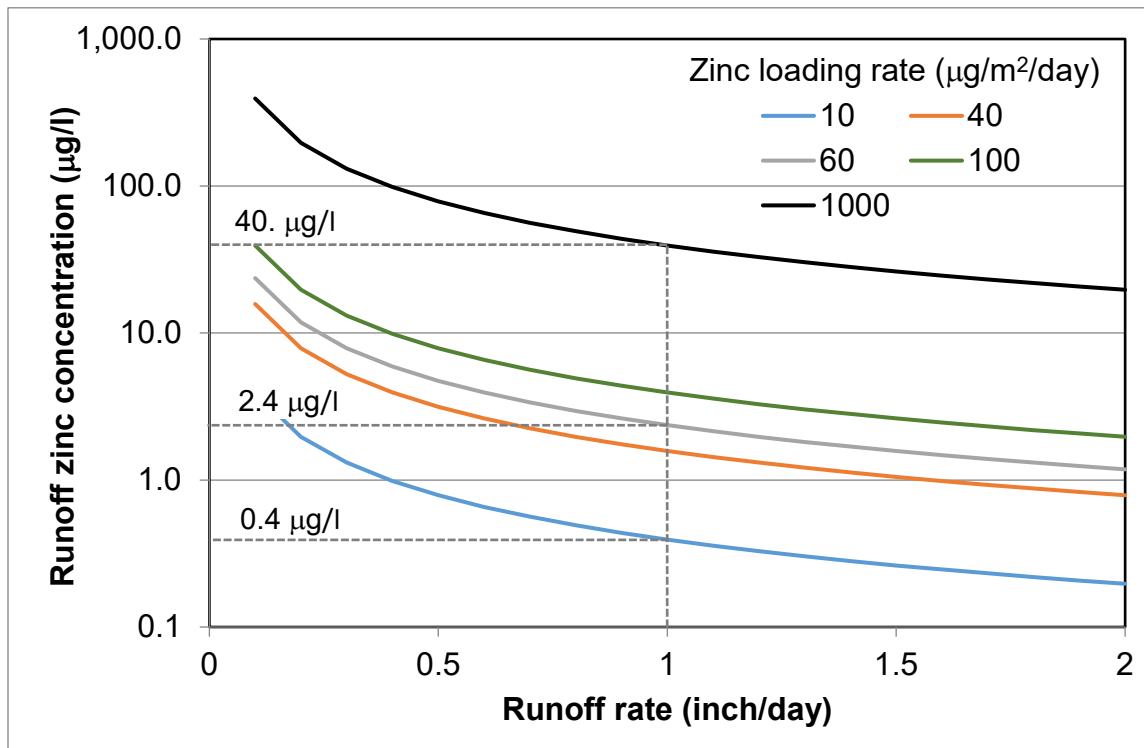
Figure 25: Zinc concentration in runoff from roadways at various zinc loading rates and runoff rates. (Reference Appendix B, Figure 25 Table)

The concentration of zinc in roadway runoff can be computed given the runoff rate from a roadway and the zinc loading rate from the roadway surface. For example, if the runoff rate is 1 inch per day and the road surface is delivering zinc at a rate of $10 \mu\text{g}/\text{m}^2$ per day, then the resulting concentration of zinc in the runoff would be $0.4 \mu\text{g}/\text{l}$ (Figure 25). At a fixed runoff rate, the relationship between zinc loading rate and runoff zinc concentration is linear, so for runoff at 1 inch per day, a zinc loading rate of $60 \mu\text{g}/\text{m}^2$ per day and $1000 \mu\text{g}/\text{m}^2$ per day results in a zinc runoff concentration of 2.4 and $40 \mu\text{g}/\text{l}$ respectively. The relationship is also linear with respect to runoff rate, so for a runoff rate of 2.0 inch per day and a zinc loading rate of $10 \mu\text{g}/\text{m}^2$ per day, the zinc runoff concentration would be $0.2 \mu\text{g}/\text{l}$.
