Investigation of Illegal Tire Dumping Sites along the Southern California-Mexico Border

California Department of Resources Recycling and Recovery

Geo-Logic
ASSOCIATES

March 15, 2023

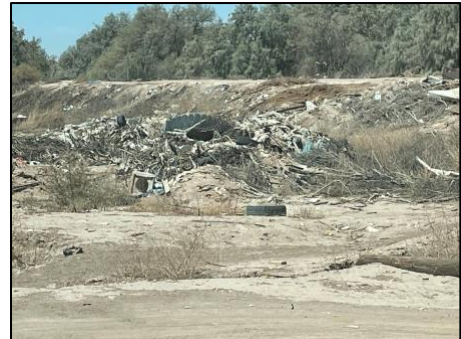
The **New River Site** (Im_New River1, Figure 2) is located approximately 1,000 feet southwest of the intersection of Dogwood Road and Highway 98, in an unincorporated portion of the County just west of the City of Calexico. The site is located to the east of the Calexico Solid Waste Site and includes partially buried to completely exposed tires, miscellaneous solid waste (scrap metal, metal pipes, plastics, textiles, and vegetative debris) dumped along an unnamed dirt road south of Dogwood Road, and into erosional rills and slopes adjacent to the New River. Based on our field investigation, the site is approximately 300 feet long and approximately 500 feet wide and comprises roughly 3,000 cubic yards of debris based on the material that was visible. To clean up this site, heavy equipment, such as a backhoe or excavator, will be needed to extract waste and load haul trucks.

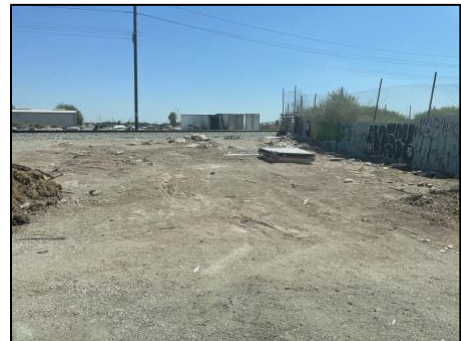
The **Williams Avenue Site** (Im_Williams1, Figure 3) is located approximately 150 feet north of Sam Ellis Street and VV Williams Avenue in the City of Calexico. The site is approximately 300 feet long by 50 feet wide. Although just a few scattered waste items were observed during the inspection, according to Mr. Martinez, various types of waste including tires, furniture and mattresses, and other solid wastes typical of illegal residential dumping have been disposed of periodically at this location. ICPHD recently cleaned up this site using a CalRecycle grant to fund operations.

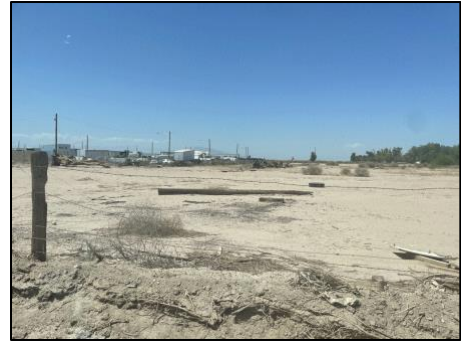
The **Maddox Road Site** (Im_Maddox1, Figure 4) is located along the east and west side of Maddox Road south of West Cole Road in an unincorporated area of Imperial County just west of the City of Calexico. The site measures approximately 1,070 feet from north to south and 100 feet from east to west. Wastes observed during the site inspection include single tires scattered and a few small piles of miscellaneous solid wastes. ICPHD recently cleaned up this site using a CalRecycle grant to fund operations, but dumping occurs periodically, and Mr. Martinez expects dumping to continue.

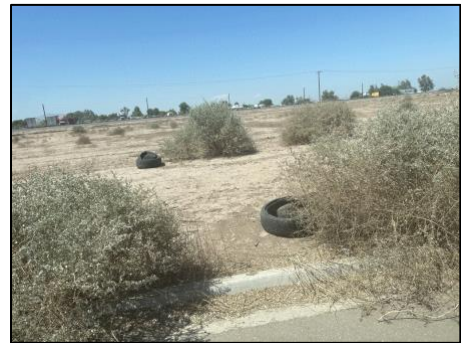
The **Towncenter Way Site** (Im_Towncenter1, Figure 5) is on the east, west and north sides of Towncenter Way and north of West Cole Boulevard in between the city of Calexico to the south and the community of Heber to the north. Although just a few scattered tires were observed during the site inspection, according to Raul Martinez, wastes have historically been scattered along Towncenter Way over an area measuring approximately 4,500 feet by 300 feet. Illegal dumping of solid waste and tires has repeatedly occurred in the past and this site has been recently cleaned up by ICPHD under a CalRecycle grant-funded program. The site is not secure, and access is not restricted; as a result, Mr. Martinez expects that illegal dumping will continue in the future.

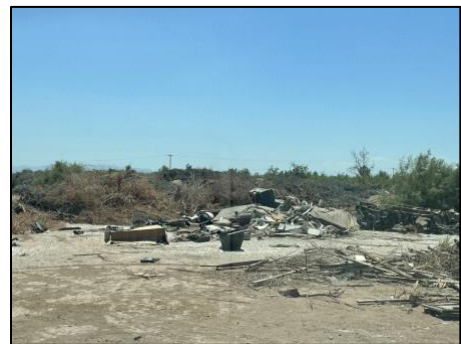
The **Jasper Road 2 Site** (Im_Jasper2, Figure 6) is located along Jasper Road approximately 700 feet southeast of the intersection of Jasper Road and Pitzer Road between the City of Calexico to the south and the community of Heber to the north. The site is a triangular parcel approximately 1,000 feet along Jasper Road and 900 feet north-south from Jasper Road to the canal. Scattered solid waste piles and tires were observed during the site inspection. Approximately 1,000 cubic yards of various solid waste and

tires, and 4,500 cubic yards of green waste and dumped vegetation waste piles were observed at the time of the visit. Mr. Martinez has periodically cleaned up this site in the past. The site is relatively secluded and surrounded by overgrown brush. As a result, illegal dumping is likely to continue at this location.

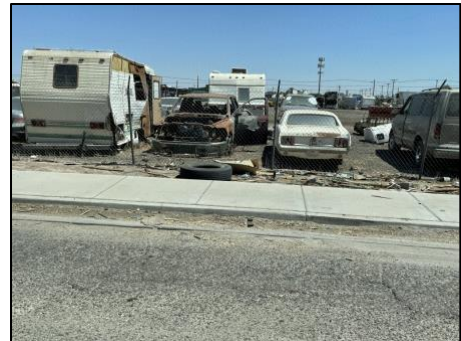
The **Portico Boulevard Site** (Im_Portico1, Figure 7) is located along the east side of Portico Boulevard north of Weakly Street in northwest Calexico. Although only a few tires were observed during the site inspections the reported area of roadside dumping along Portico Boulevard extends roughly 500 feet north of Weakley Street and is roughly 50 feet wide. Illegal dumping is likely to continue at this location because it is visually shielded by transport truck and motor homes that use the area for extended parking and repairs.

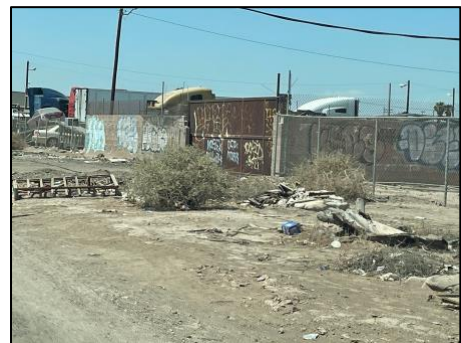
The **Weakley Street Site** (Im_Weakley1, Figure 7) is located on the north and south sides of Weakley Street and primarily east of Portico Boulevard, and west of Scaroni Avenue in the northwestern portion of the City of Calexico. Based on field observations, the site consists of dumping along the north and south side of Weakley Street and extends west of Scaroni Avenue approximately 630 feet. Waste debris consists of miscellaneous solid waste and tires scattered adjacent to the road. Mr. Martinez reported that this site was cleaned up recently using CalRecycle grant funds for operations. The reemergence of illegal waste piles after the recent waste removal operation indicate the likelihood that illegal dumping will continue at this site.

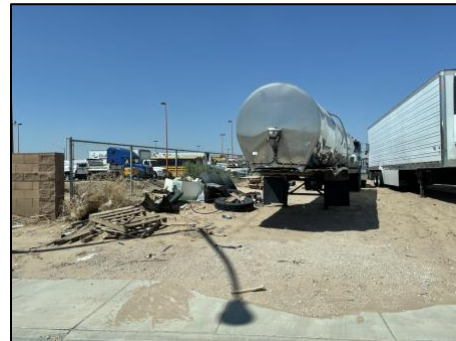
The **Meadowlark Road Site** (Im_Meadowlark1, Figure 8) is located along the east and west side of Meadowlark Road between Gateway Road and an unnamed road to the north, in the eastern part of the City of Calexico north of the Calexico East Port of Entry. During the field investigation, the only area where waste was observed was an area measuring approximately 70 feet by 80 feet on the west side of Meadowlark Road. In addition, although no waste or tires were observed at the time of inspection, Mr. Martinez reported that illegal dumping also occurs on a few vacant lots surrounding the Meadowlark site. Mr. Martinez reported that the now-vacant lots were cleaned up recently by ICPHD using CalRecycle grants to fund the operations. Due to the proximity of local transport and storage facilities that provide visual shielding, Mr. Martinez believes illegal dumping will continue at this site.

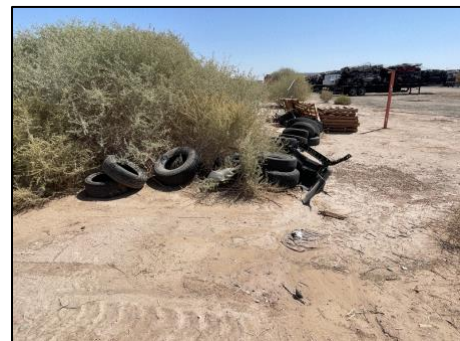
The **Gateway Road Site** (Im_Gateway1, Figure 8) is west of the intersection of Gateway Road and Menvielle Road in the vacant land west of the Gateway Road cul-de-sac and northwest of the De Anda Trucking and Storage site, in the eastern part of the City of Calexico and north of the Calexico East Port of Entry. Solid wastes, including numerous waste tires, were observed to the north, west, and southwest of the cul-de-sac and dispersed throughout an area approximately 460 feet long and approximately 60 to 80 feet wide around the north and west side of the road. In addition to the tires, wastes consisted of wooden pallets, furniture, discarded machinery, auto parts, and construction and demolition debris. This site is periodically cleaned up by ICPHD using CalRecycle grants to fund the operation. Mr. Martinez believes that dumping will continue to occur at this site because the Gateway Road site is close to the De Anda Trucking and Storage site, and the site is relatively hidden from the road by shrubbery but easy to access from the road.

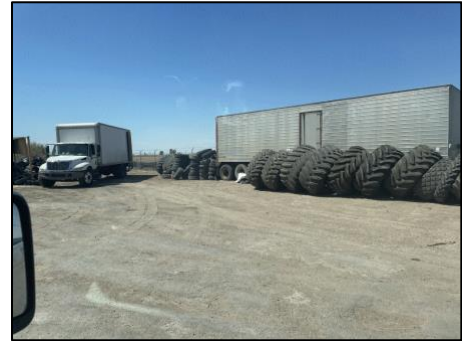
The **Bonanza Site** (Im_Bonanza, Figure 9) is located at 2093 Old Highway 111 in an unincorporated area of the County just east of El Centro, and approximately 0.3 miles north of the intersection of Old Highway 111 and East Evan Hewes Highway (S80). The lot is roughly 1.1 acres and is currently a new and used retail tire business that was previously abandoned. The ICPHD reported that the previous owner left approximately 4,000 tires on the property. Mr. Martinez stated that the new owner was funding operations to process, or cut tires, and haul to local landfills. During the site investigation, many tires were being cut into fours and the side walls were being removed. No information was provided on how the processed tires would be managed.

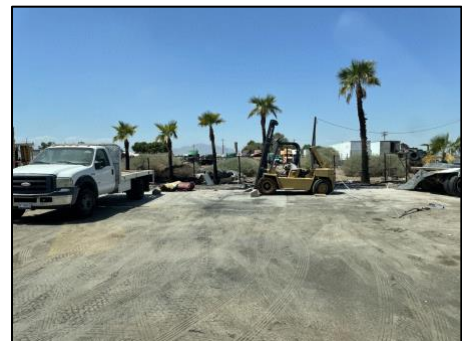
The **Rocha Trucking & Parking Site** (Im_RTP1, Figure 10) is located at 25 Anza Road in an unincorporated area of Imperial County just southwest of the City of Calexico and is approximately 700 feet north of the international border. Rocha Trucking and Parking (RTP) is an active business with an 8-acre lot. Discussions with the owners revealed that there are two transport trailers on site full of tires collected that were dumped on site and from offsite collection along Anza Road. The owner would like assistance with disposal of these waste tires, if available.

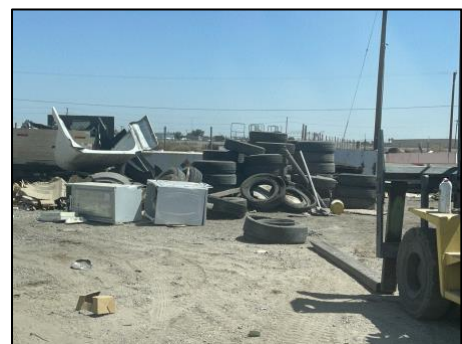
The **Ramza Incorporated Site** (Im_Ramza, Figure 11) is located at 546 Maddox Road in an unincorporated area of Imperial County just west of the City of Calexico. The roughly 7.25-acre site is an active waste tire storage and hauling facility. At the time of inspection, GLA observed numerous tire piles scattered around the site and many stored trailers. The owner was not available at the time of the inspection, but Ramza Inc. is a registered waste tire hauler in Imperial County.

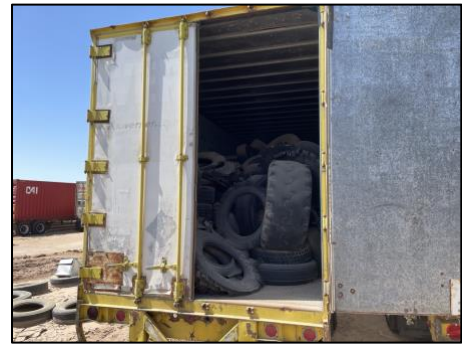
The **De Anda Trucking Site** (Im_De Anda, Figure 12) is located at 1632 Gateway Rd #1 in eastern Calexico just north of the Calexico East Port of Entry. The roughly 23-acre site consists of a scale house, transport truck and trailer storage, and a repair shop. Discussions with the owner on site revealed numerous transport trailers filled with tires and many waste tires visible on the ground at the site. It is estimated that approximately 3,000-4,000 tires may be stored on this property at the time of the field visit.

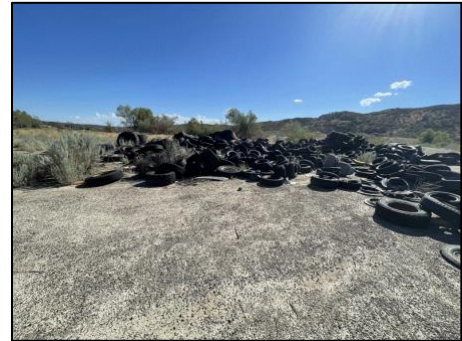
The Campo Band of Mission Indians reported a tire dump site on reservation lands in San Diego County, west of the community of Live Oak springs, approximately 2.4 miles southwest of the Golden Acorn Casino and west of Church Road. Representatives from the Tribal Environmental Health Department and GLA visited the site (SD_Campo1, Figure 14) on August 31, 2022. The site, which was previously a strip mine for aggregate construction materials such as sand and gravel, was barricaded preventing public vehicle access from Church Road. During the site investigation GLA located approximately six piles of tires at the site, ranging from small piles with around ten tires to one larger pile with approximately 300 to 500 tires, totaling approximately 600 to 800 tires. Additional dumping was observed at the site and materials ranged from auto and truck frames and/or parts, cured concrete washout, old mining equipment, oil tanks and construction/demolition wastes. This area is managed by the Tribal Environmental Health Department who have expressed interest in receiving assistance from CalRecycle with tire disposal, if available.
