Tire-Derived Aggregate: Settlement in Road Slide Repair

Analysis Of Marina Drive, Geysers Road, Sonoma Mountain
Road, Palomino Road, Italian Bar Road, Moran Road, And
Ortega Ridge Road Repair Projects

December 2023

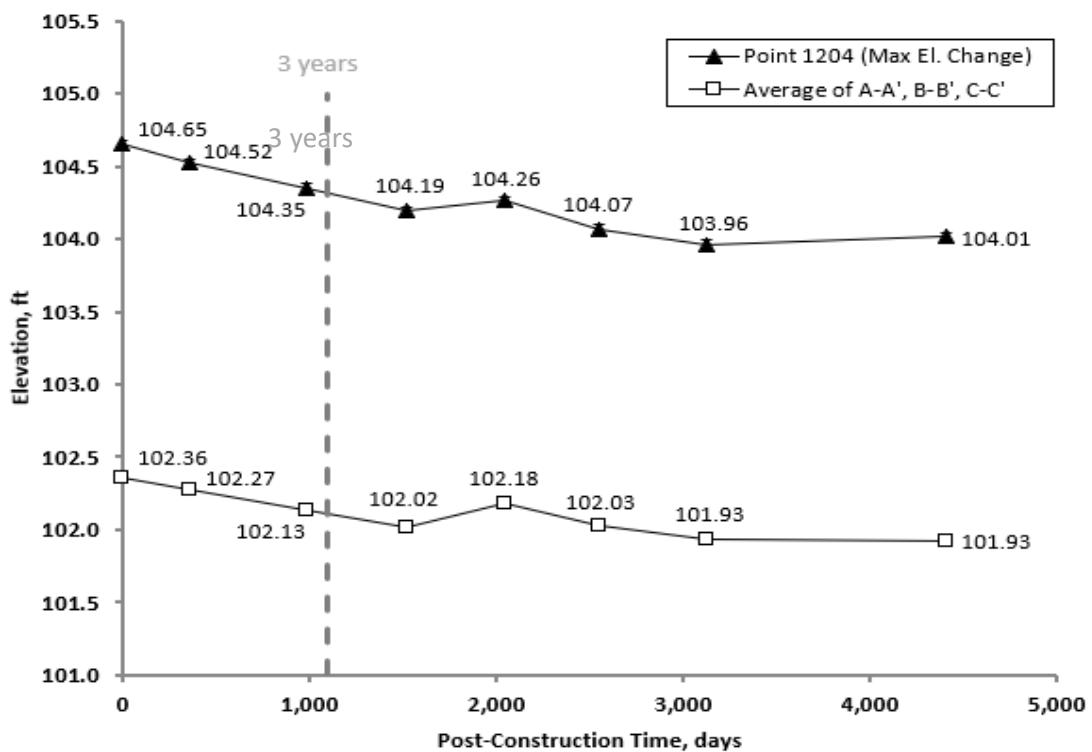
Figure 10. Average and Maximum Elevation Change vs. Time at Sonoma Mountain Road

The cross-sections A-A', B-B', and C-C' through the TDA fill portions of the Sonoma Mountain Road repair indicate an overall average settlement of 0.44 feet (5.28 inches) since the completion of construction. The approximate maximum settlement observed was 0.69 feet (8.28 inches) at survey point 1204 (refer to Figure 9).

Analysis of the average settlement between 2018 and 2021 for this site reveals no settlement of the TDA fill, however, there is a slight increase in elevation at point 1204. This data point was derived from the asphalt surface and not from the previously installed survey nail, which could not be located. Consequently, this data point may potentially reflect the same value as the previously recorded 2018 elevation data.

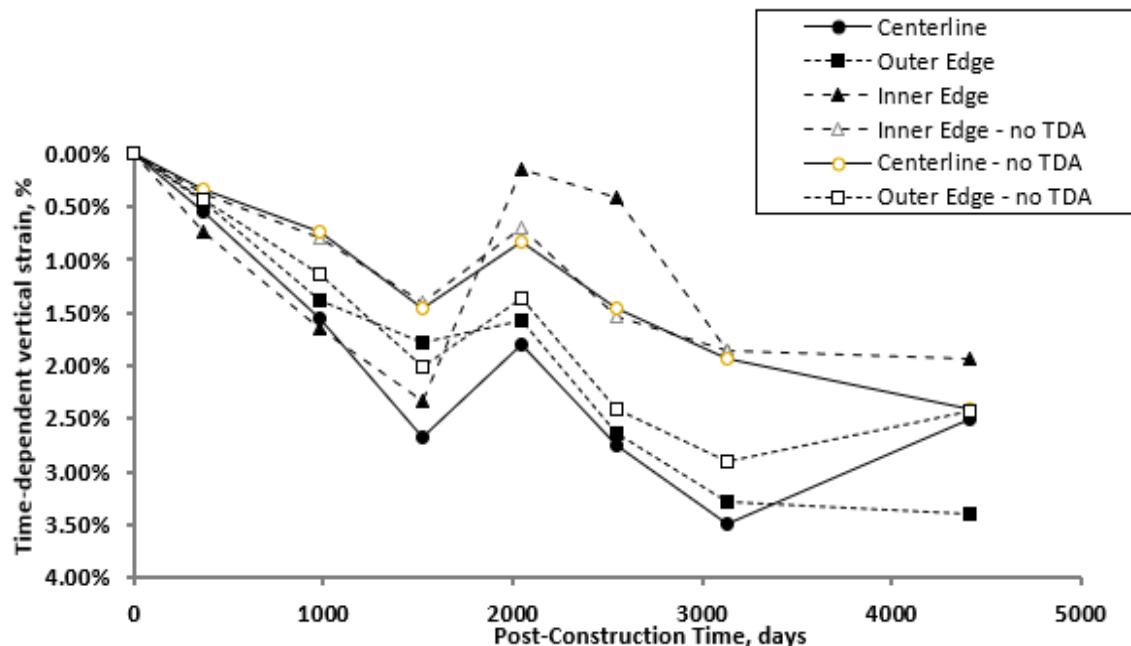
Figure 11. Sonoma Mountain Road: Time-dependent Settlement for the Inner Edge, Outer Edge, and Centerline Alignments

Based on the survey data depicted in Figures 5, 8, 11, and 14, no significant correlations were found between TDA roadway alignments and the time-dependent settlement rates of TDA. Consequently, the data sets from each project site were plotted together to determine the average Type B TDA settlement over time. All data points from previous surveys for Geysers Road, Marina Drive, and Sonoma Mountain Road were used to generate the graph. However, the settlement data from the Palomino Road site were not relevant or comparable to the other sites discussed in this report, therefore, they were excluded from the curve in Figure 15. The time-dependent vertical strain from each of the road embankment projects was plotted against the post-construction time (Figure 15).

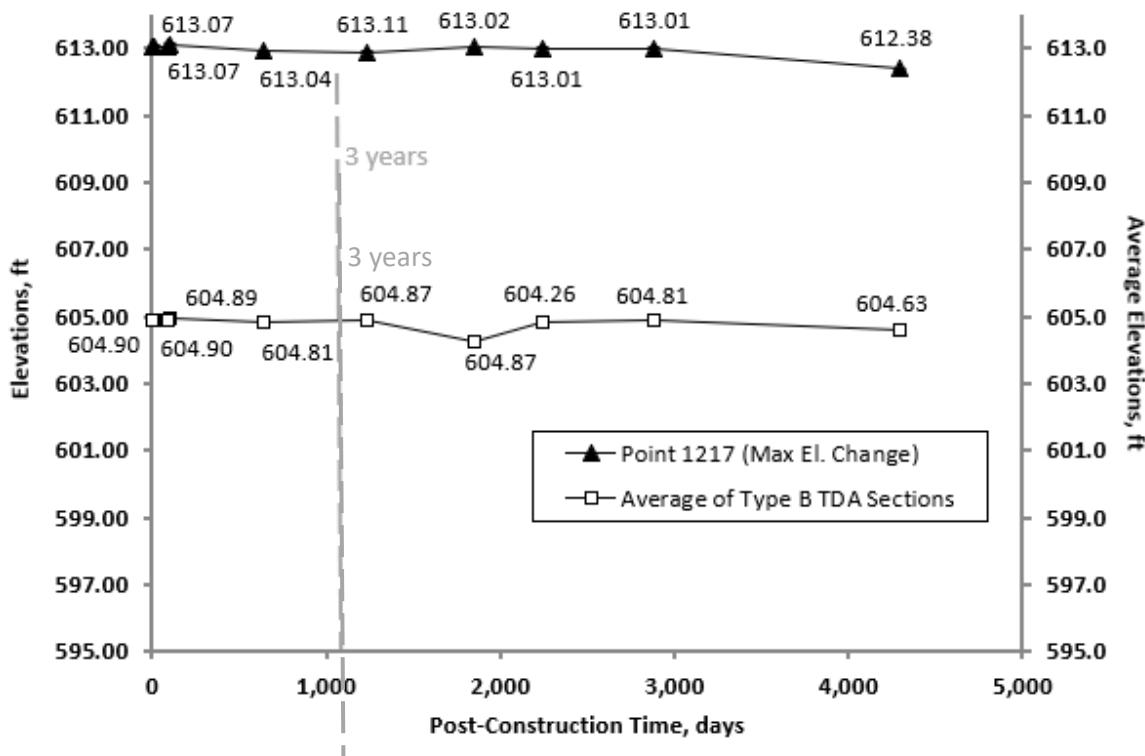
Figure 13. Average and Maximum Elevation Change vs. Time at Palomino Road

outside edge of the project. The average settlement over TDA cross sections is 0.33 feet or 3.96 inches.

This project used a 3-foot TDA fill under the engineered road section, and the global stability of the hill on which the road sits is known to be unstable. Additionally, various sections further north on the road have undergone repairs, including tiebacks and retaining walls, due to creep and global movement over the years. Given the uniqueness of this project, the settlement data was not incorporated with the data from the other three sites to develop the settlement curve for 5- to 15-foot TDA fill volumes.

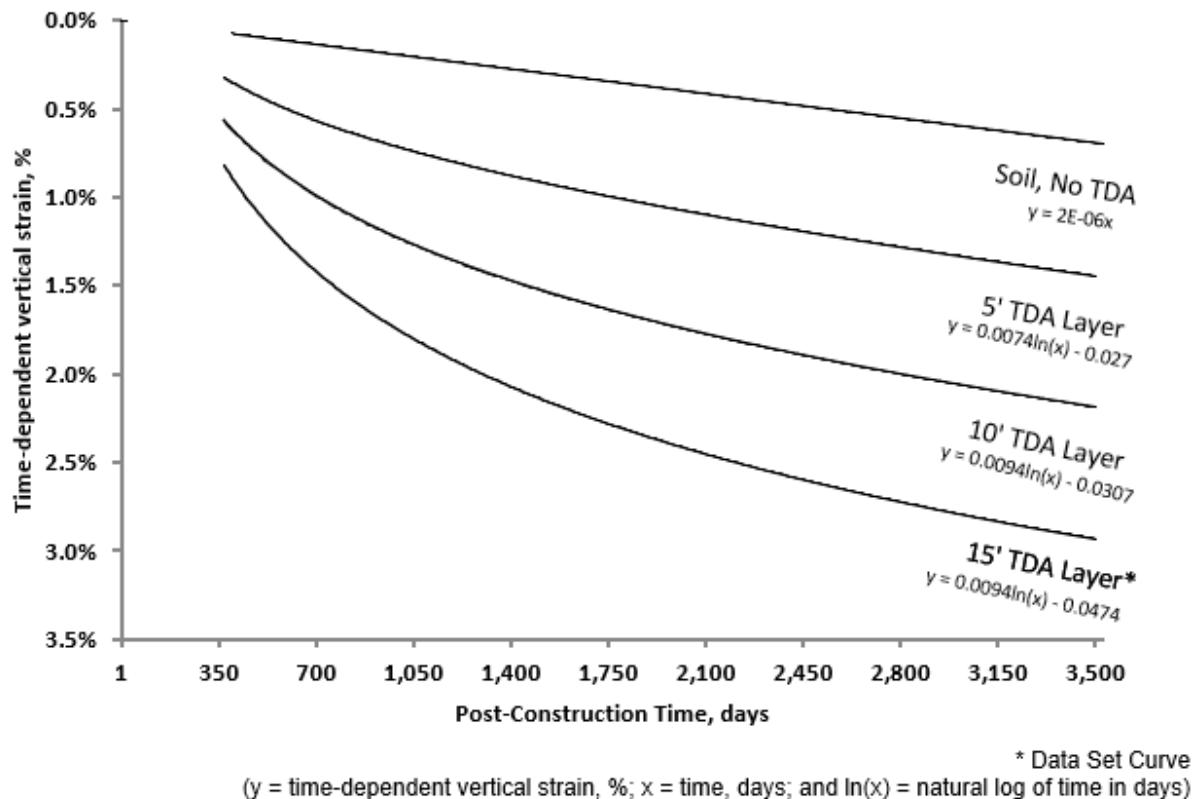
Figure 16. Estimated Settlement Rates by TDA Layer Thickness

Using survey data for both soil layers and 15-foot TDA layers from Figure 15, settlement rates for TDA layers of 5 feet and 10 feet were interpolated and plotted in Figure 16. This figure provides insights into the settlement behavior of TDA layers of varying thicknesses (5 feet, 10 feet, and 15 feet) over a 10-year period, offering valuable guidance for design and construction purposes as illustrated in Figure 12.

Based on survey data and field observations collected thus far for Marina Drive, Geysers Road, and Sonoma Mountain Road, a time-dependent settlement curve has been developed. The curve suggests that the rate of TDA settlement typically follows a logarithmic trend, with significant decreases observed after three years (1,095 days). While primary settlement can be minimized by placing a surcharge amount (i.e., overbuild) following the procedure outlined in Appendix D, long-term, time-dependent settlement of Type B TDA can be estimated using the curve illustrated in Figure 16 or the following equations shown in Table 4.
